Subject: Potential Violation for Unauthorized Diking of Suisun Tidal Marsh

## Suisun Club 801 – Buckler Point: Historic Aerial Interpretation

7-20-2015

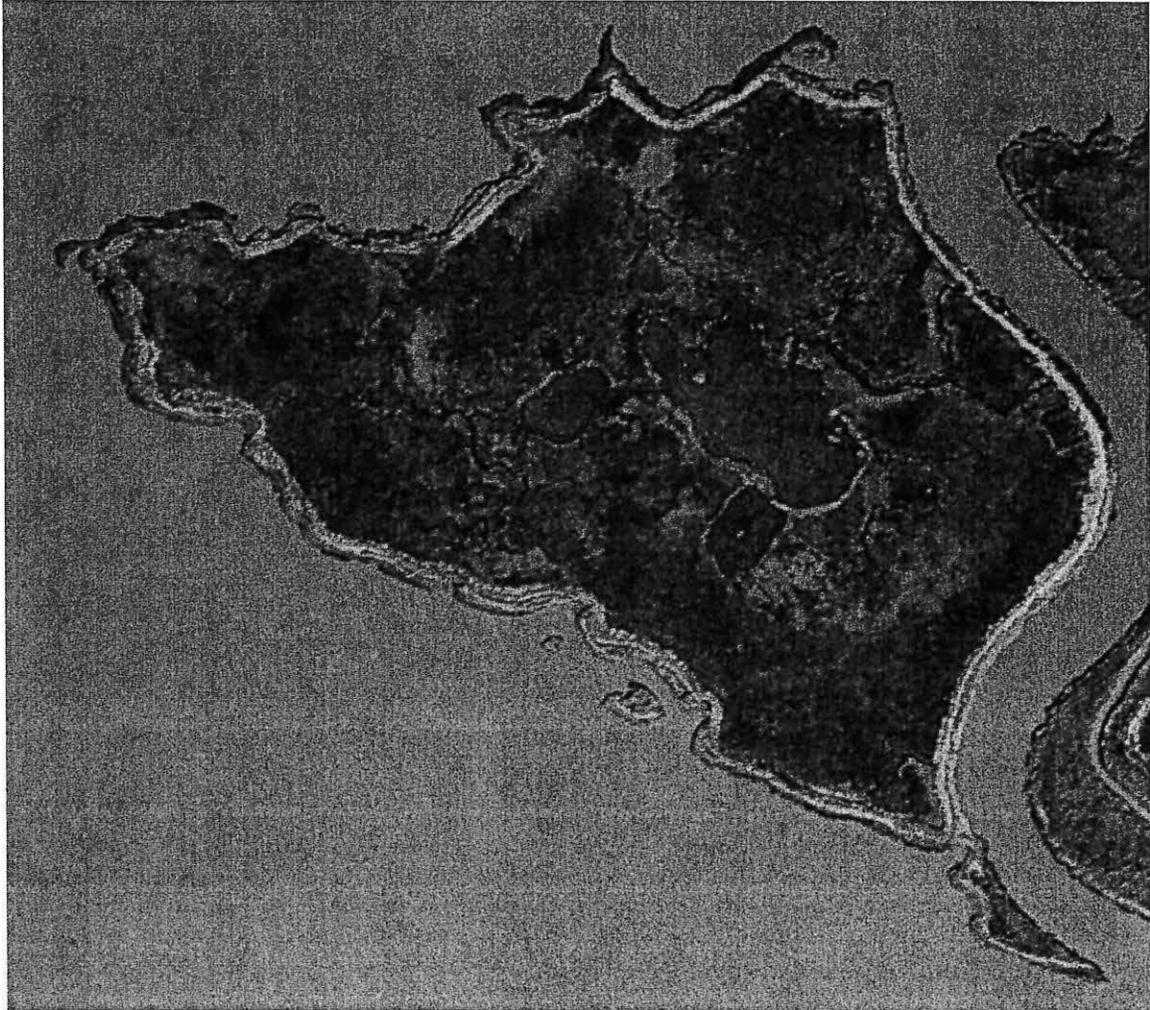
**February 12, 1948:** Levees are not readily apparent; light areas bounding the island appear to be naturally deposited berms/high marsh consistent with other isolated islands in southern Suisun Bay (e.g. Roe Island, western undiked portion of Ryer Island). No borrow ditches are evident. The island has tidal sloughs and an extensive interior pond. (USGS high-res imagery)

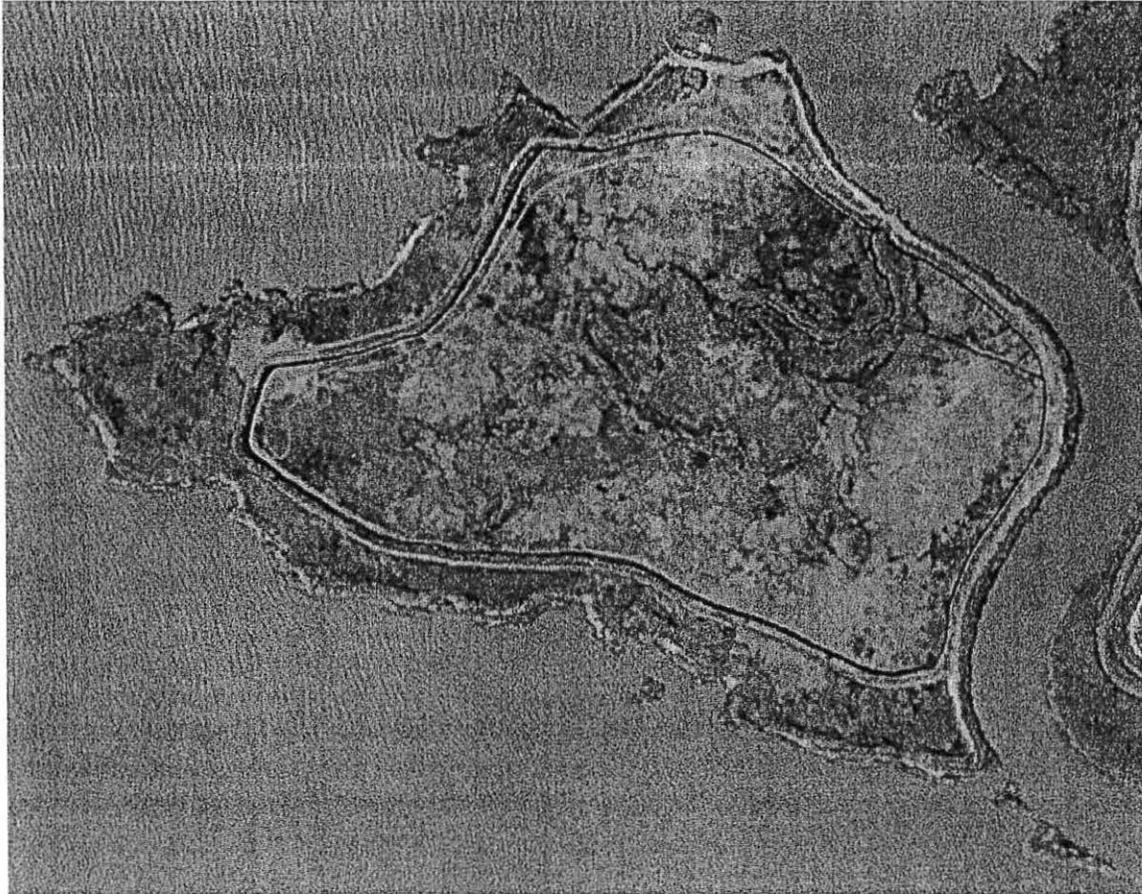
**July 21, 1958:** Levee construction in the island interior is obvious, and a structure has been built on the island's northern side. Areas inside the levee are isolated from tidal action. (USGS high-res imagery)

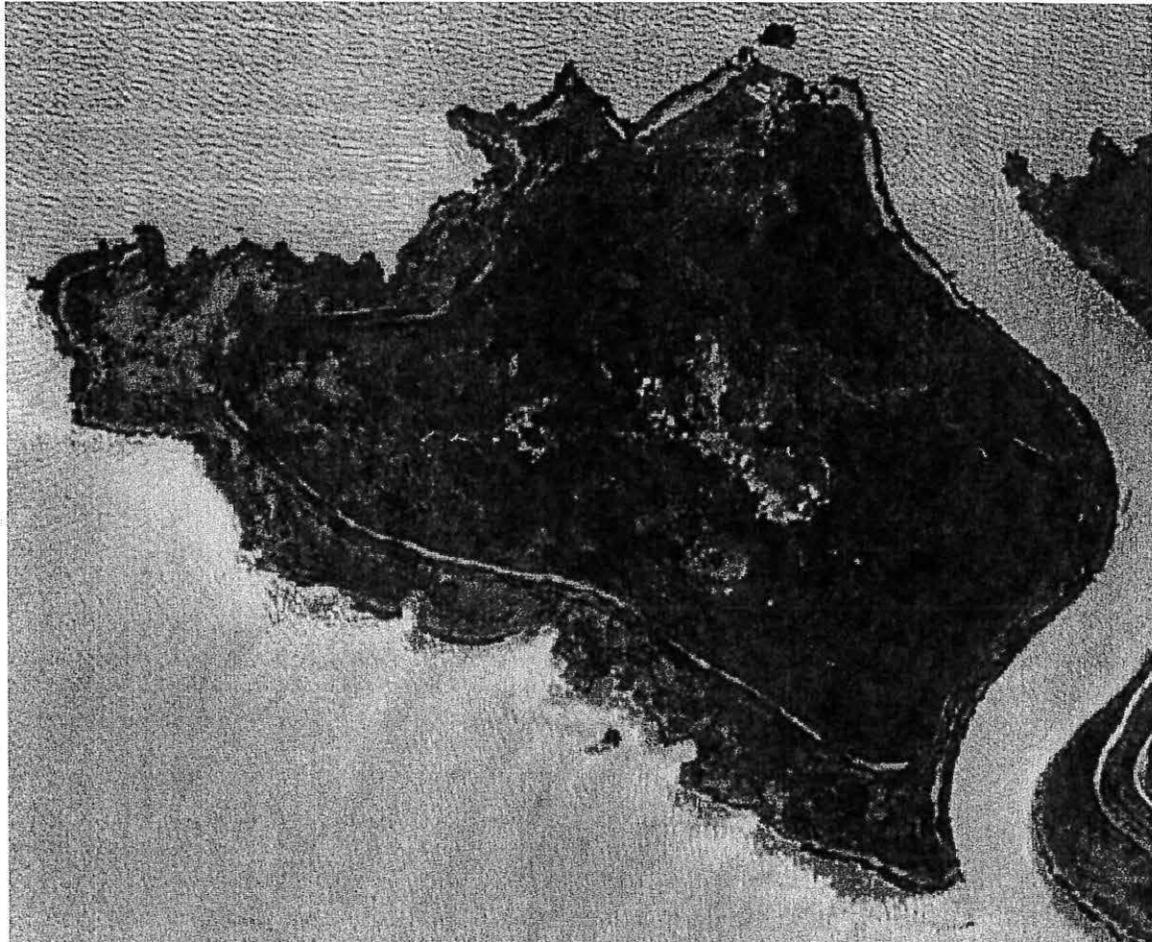
April 22, 1968: Areas within the levees appear to be managed to favor open water (duck hunting) conditions, but levee integrity is unclear. (USGS high-res imagery)

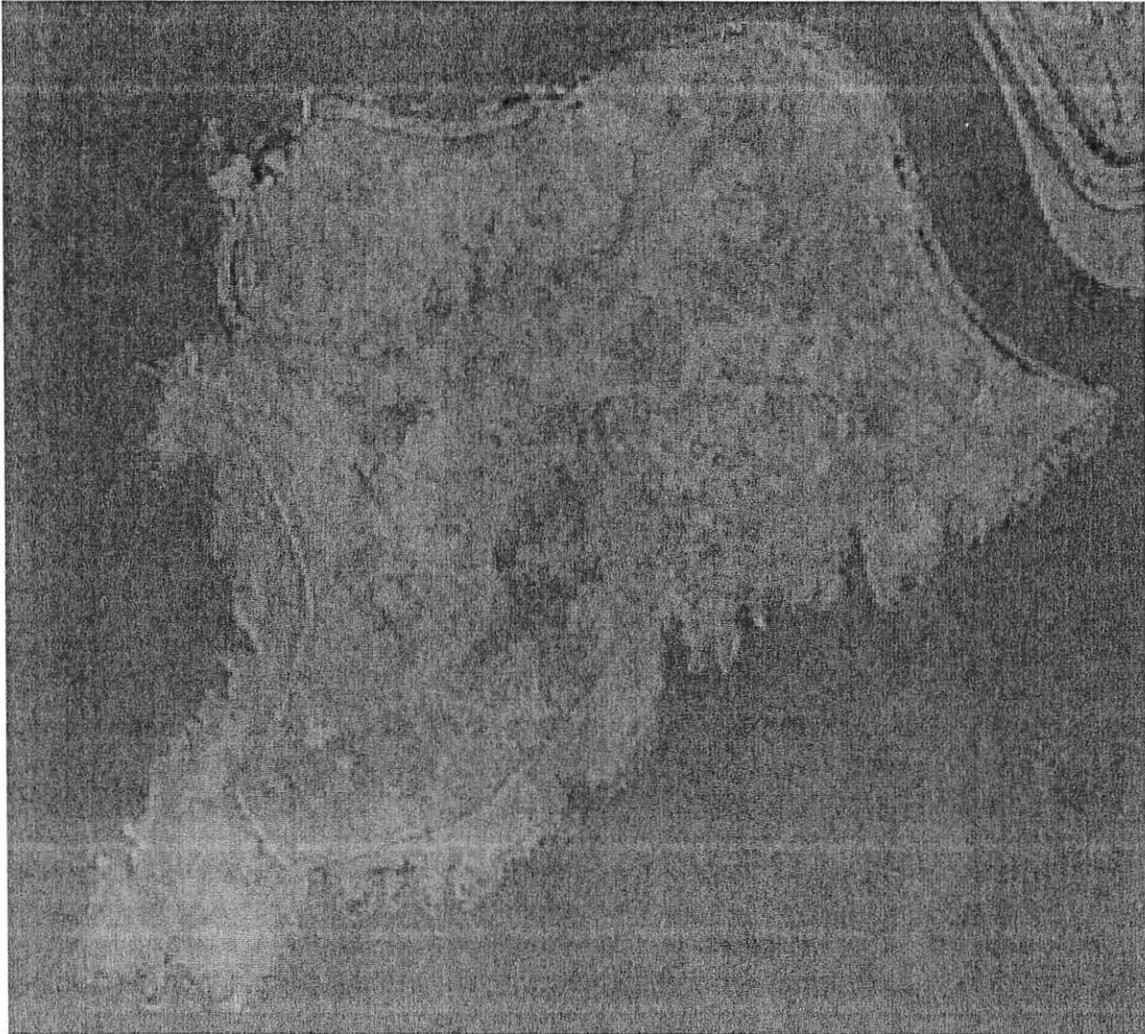
**October 3, 1973:** The integrity of the levees along the north side of the island continues to be unclear; the island may be open to tidal action. A pier/boat landing appears to have been constructed on the island's northern tip. (USGS medium-res imagery; photo is rotated slightly counterclockwise relative to other photos)

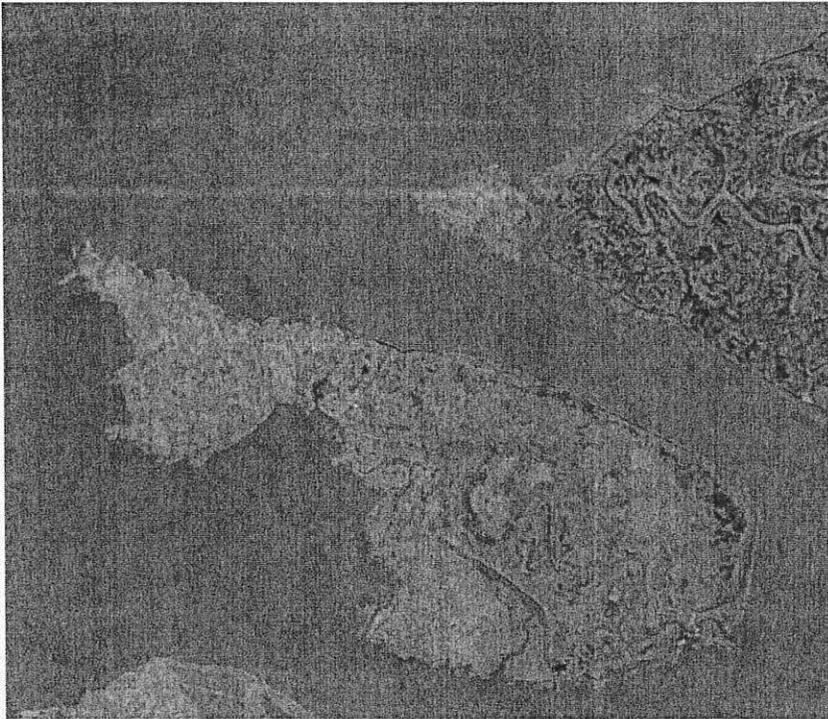
July 17, 1974: Wetlands in the island display appear to be unmanaged, and display no obvious visual differences from fully tidal habitats in Roe Island and western Ryer Island: (USGS medium-res imagery)

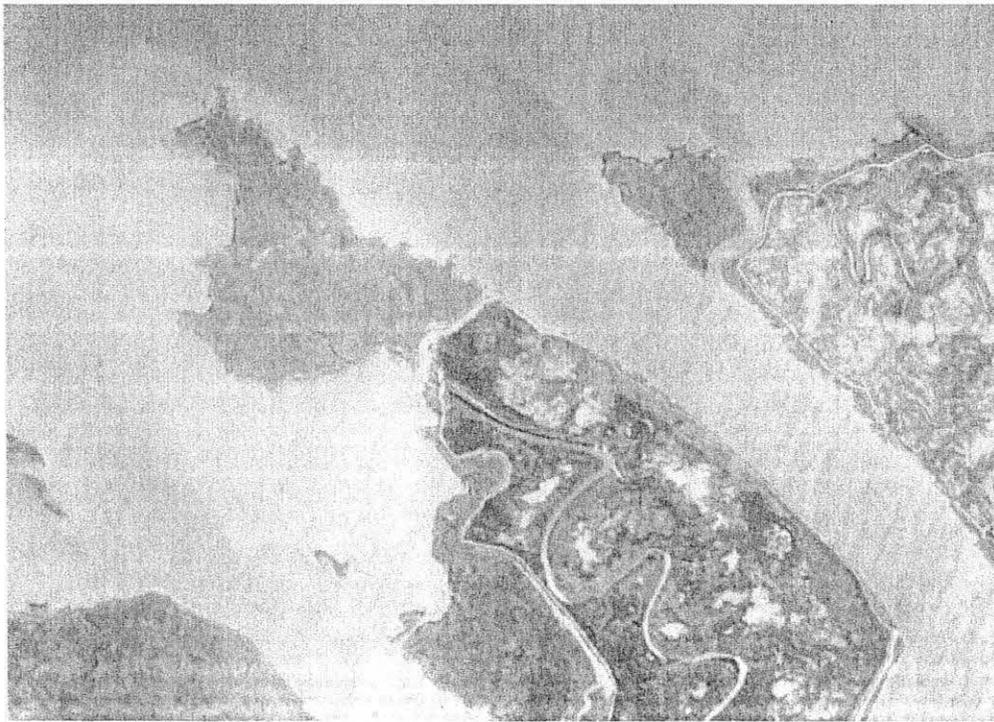
Infrared imagery from May 28, 1975 underscores the resemblance: (USGS medium-res imagery)

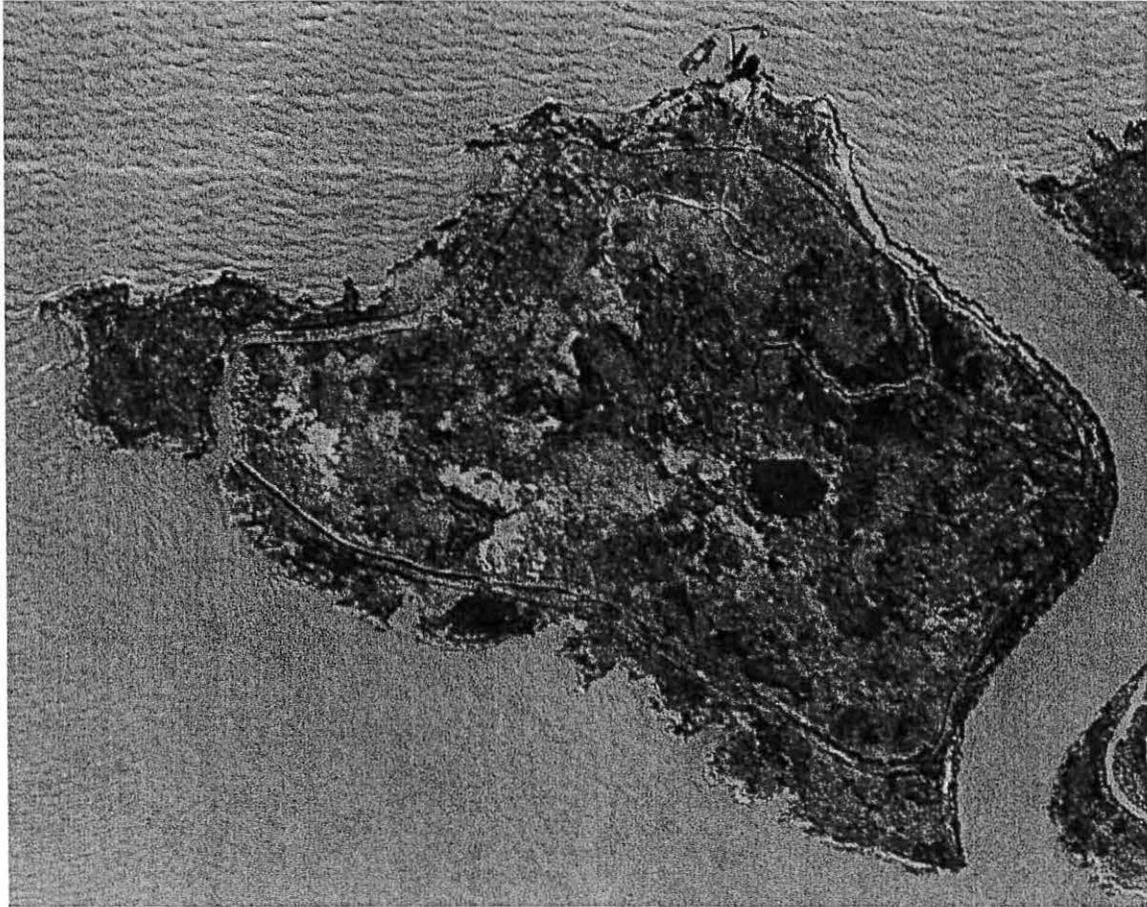
**February 20, 1981:** The island is open to the tides, with a sizeable levee breach in its southwest corner. Breaches may also exist along the island's northern side. (USGS hi-res imagery)

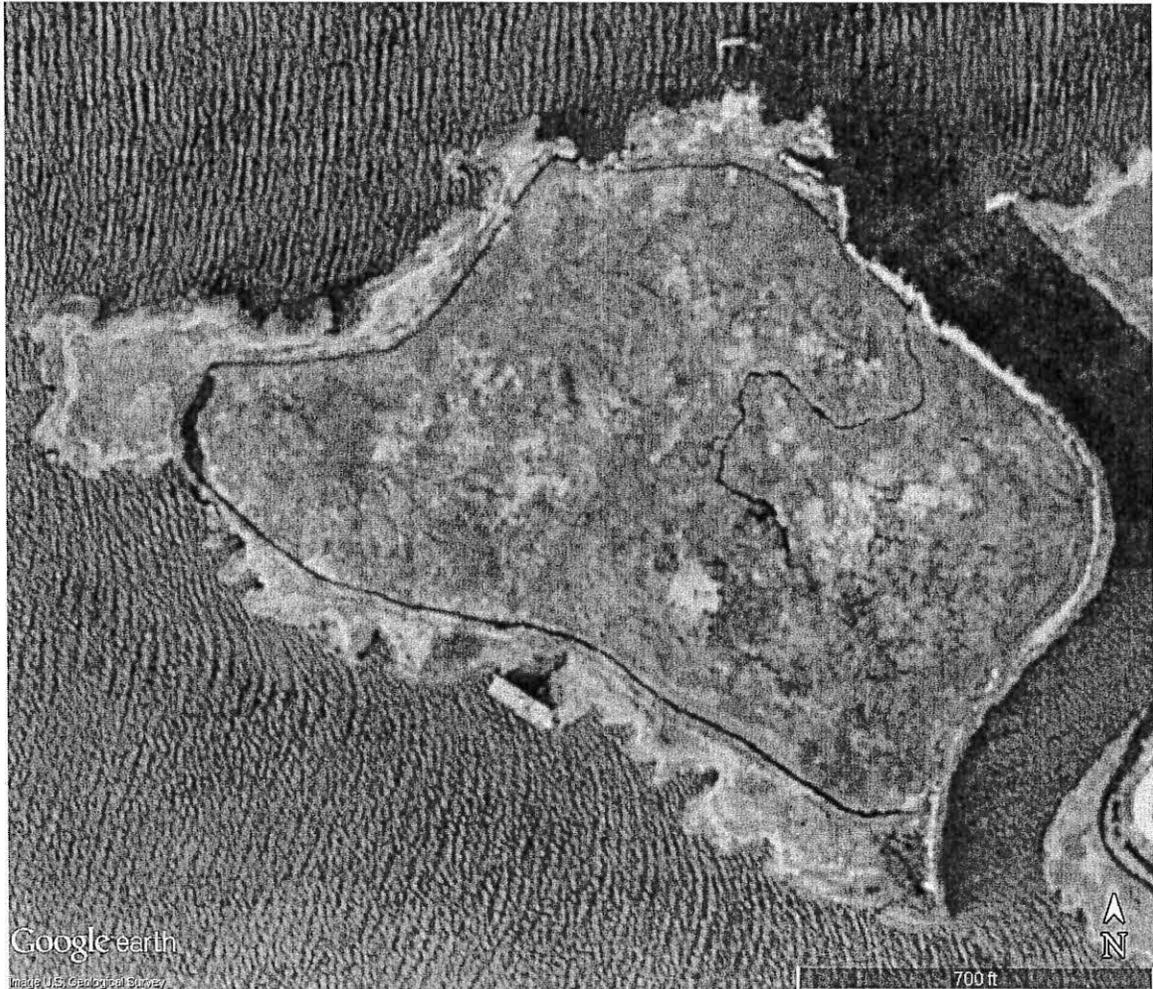
**July 13, 1988:** The large levee breach in the site's southwest corner appears to have been partially repaired, but tidal action continues through a breach into the island's northern borrow ditch. (Google Earth)

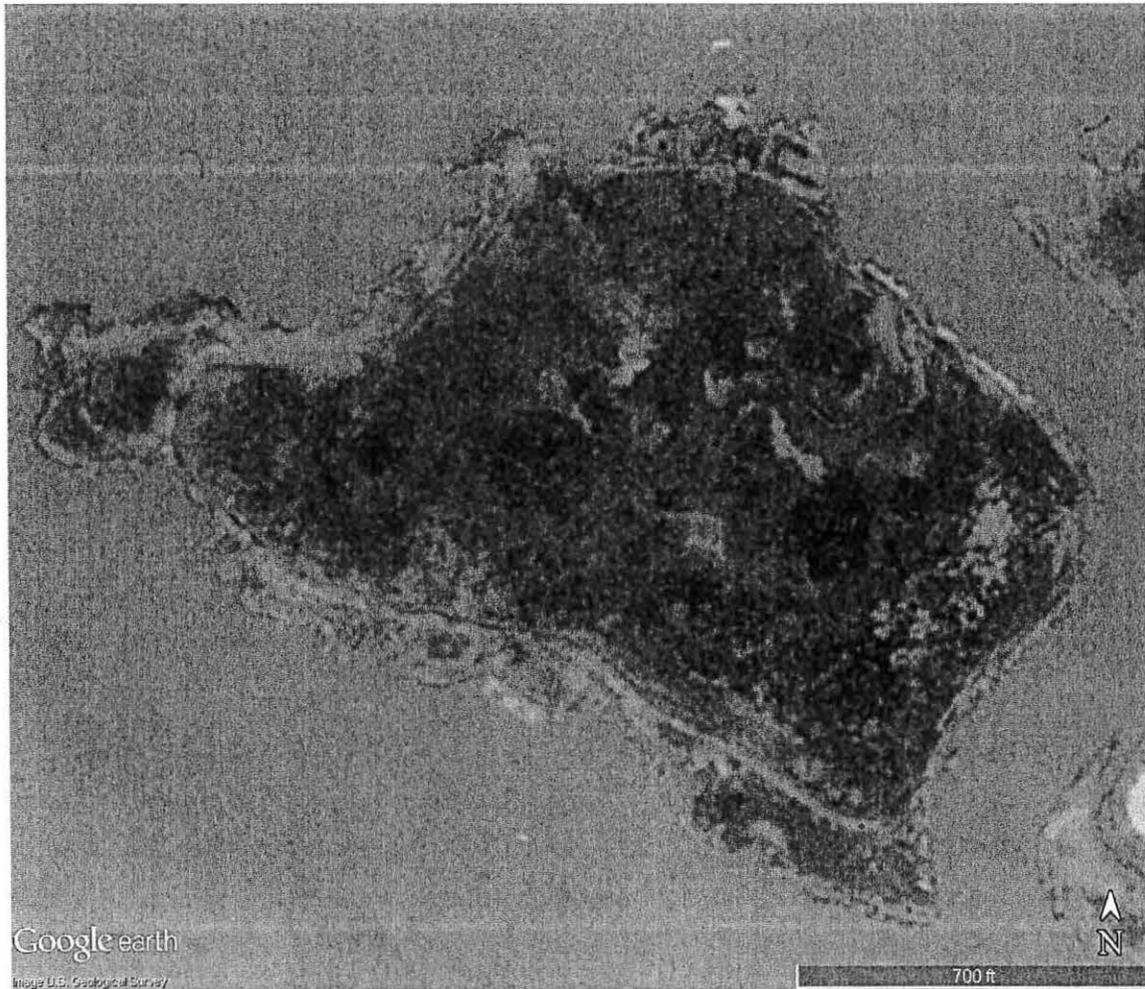
**June 15, 1983:** Breaches along the site's northern boundary enlarge; the island continues to be fully tidal. The breach in the island's southwest corner has re-opened (if it was ever closed). (Google Earth)

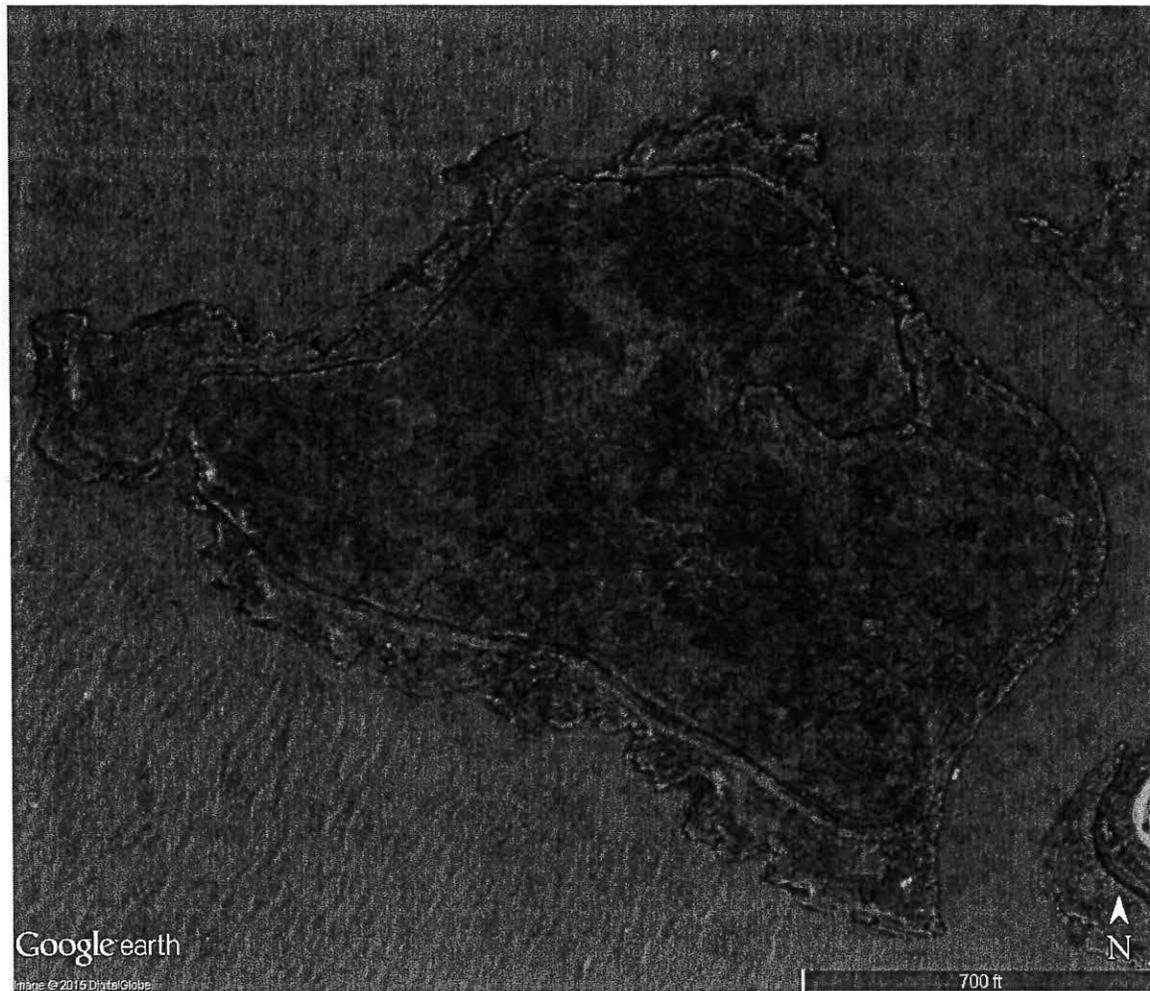
**July 27, 2002:** The island is still fully open to the tides, with the southwest and northern breaches still evident. Notably, berm/high marsh areas along the island's northeast side have retreated, increasing tidal action in a slough that reaches into the former pond area. (Google Earth)

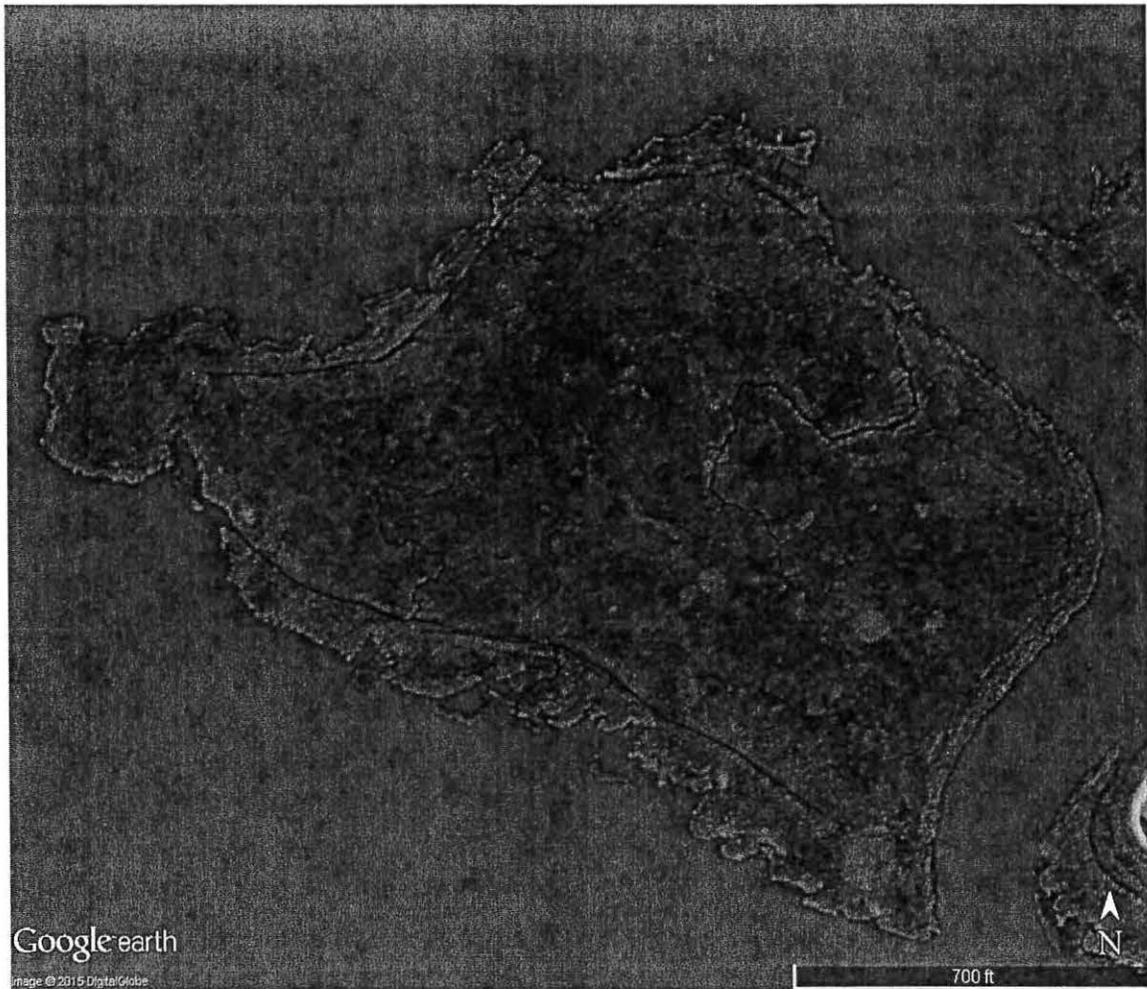
September 18, 2011: The island continues to be fully tidal. (Google Earth)

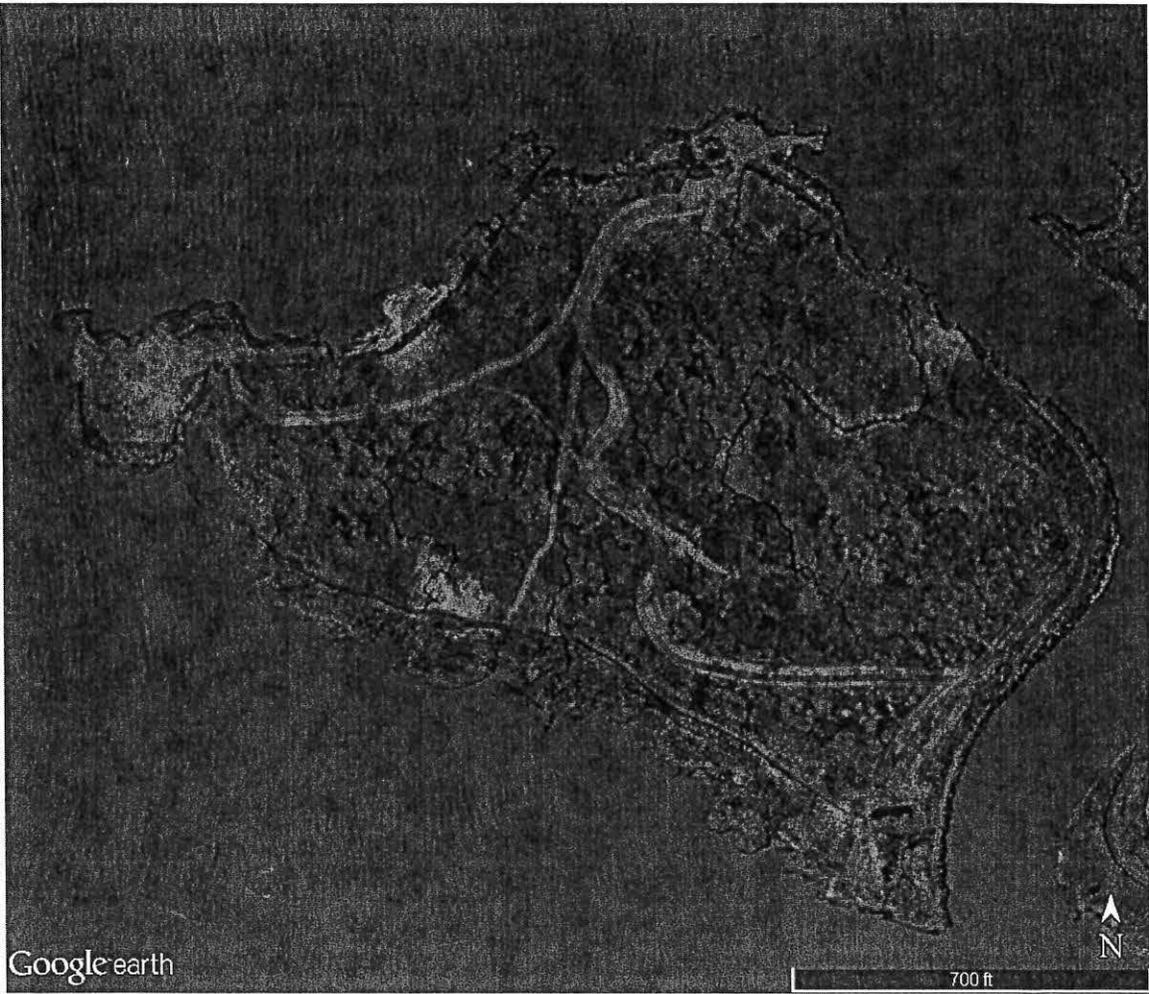
May 19, 2012: The island continues to be fully tidal, though mechanical mowing equipment has cut broad swaths through the island's vegetation. (Google Earth)

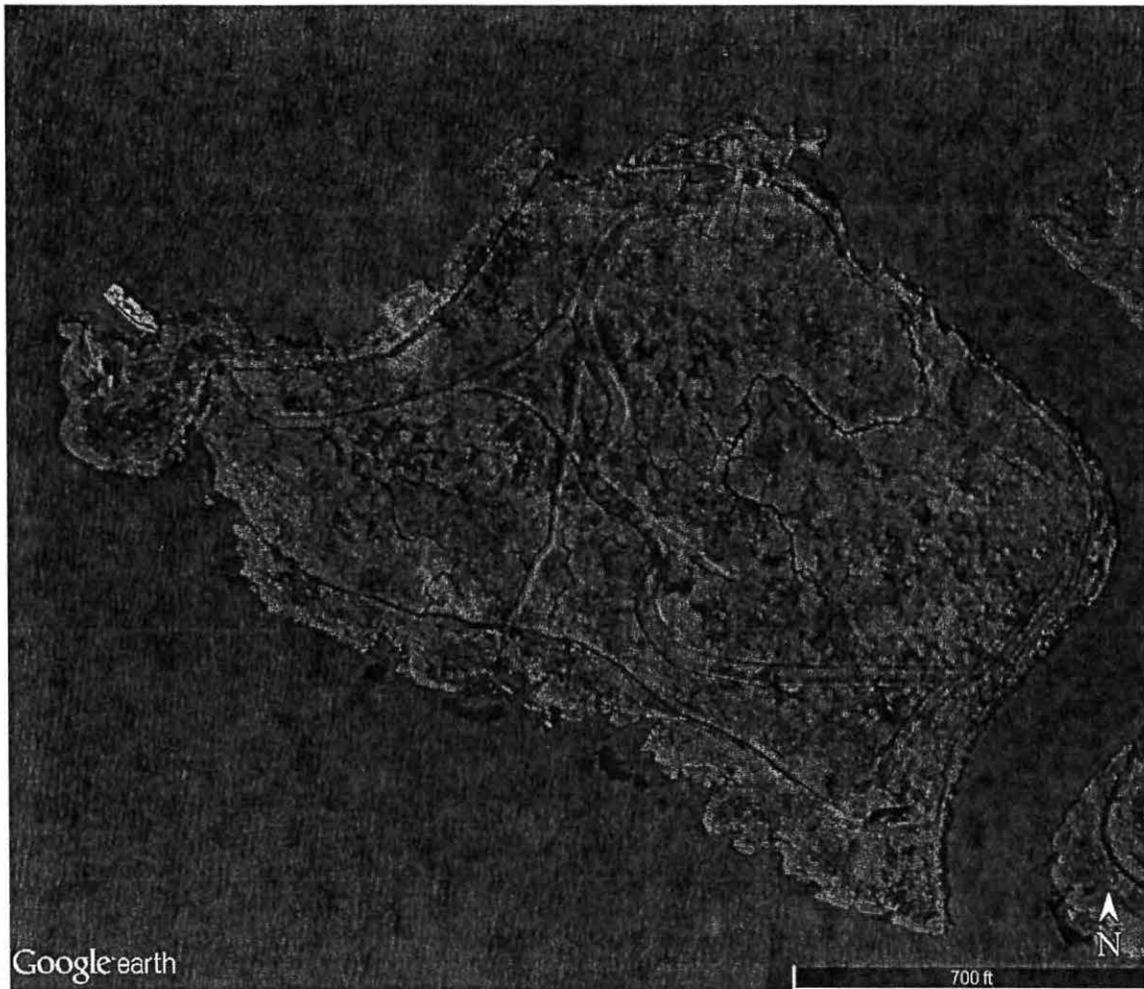
August 23, 2012: A boat and two small structures appear at the island's western tip. (Google Earth)

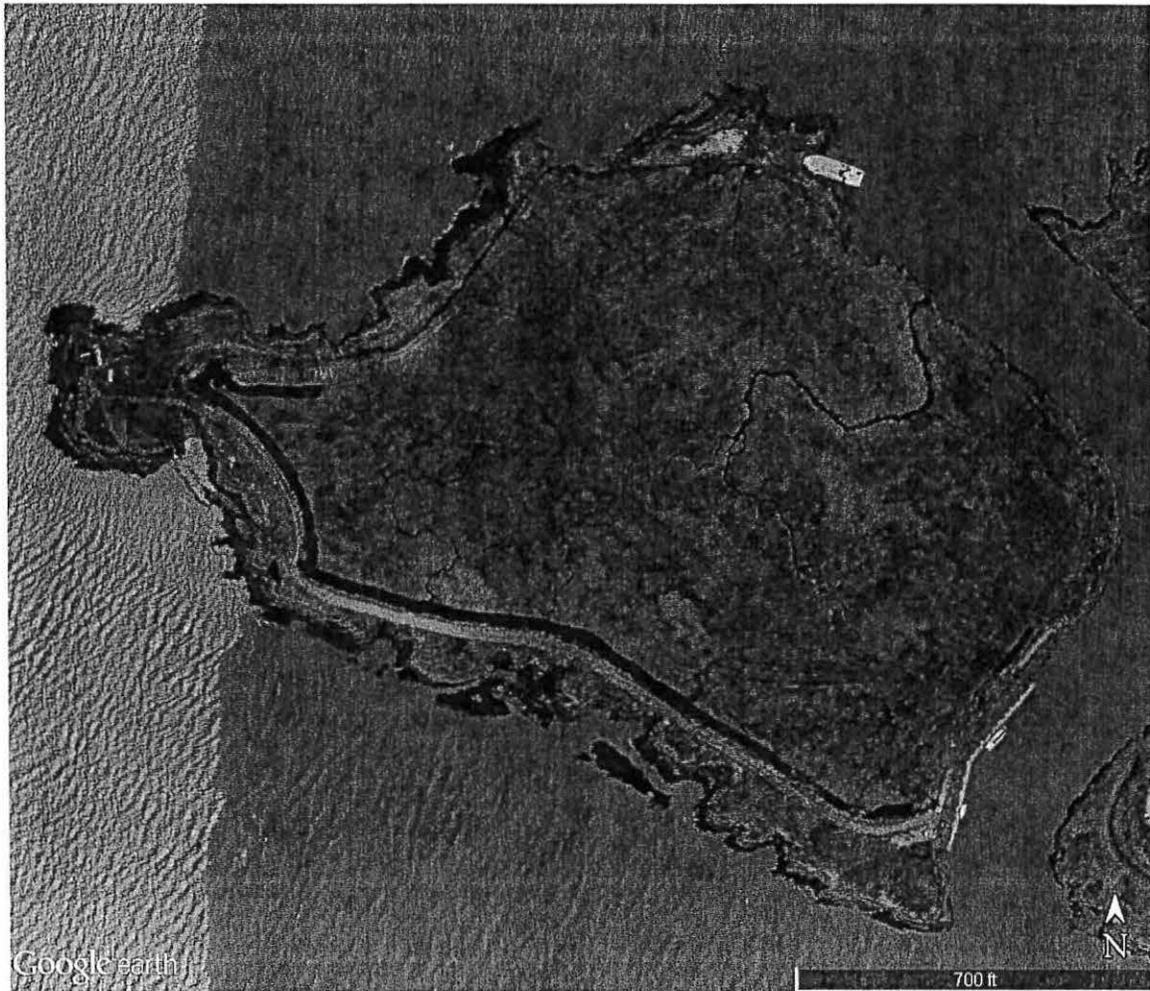
**May 26, 2014:** Levee construction is initiated at the island's southeast corner, working clockwise around the island. Multiple boats, piers, and structures can be observed, as well as the excavator constructing the new levee. The new levee generally follows the rough alignment of the 1958 levee, except in the island's westernmost tip, where it deviates considerably. The levee cuts off tidal action through the island's southwest corner, but tidal action continues through the northern sloughs and 1948 borrow ditches. The new levee footprint appears to be placed on top of the 1948 borrow ditch. (Google Earth)

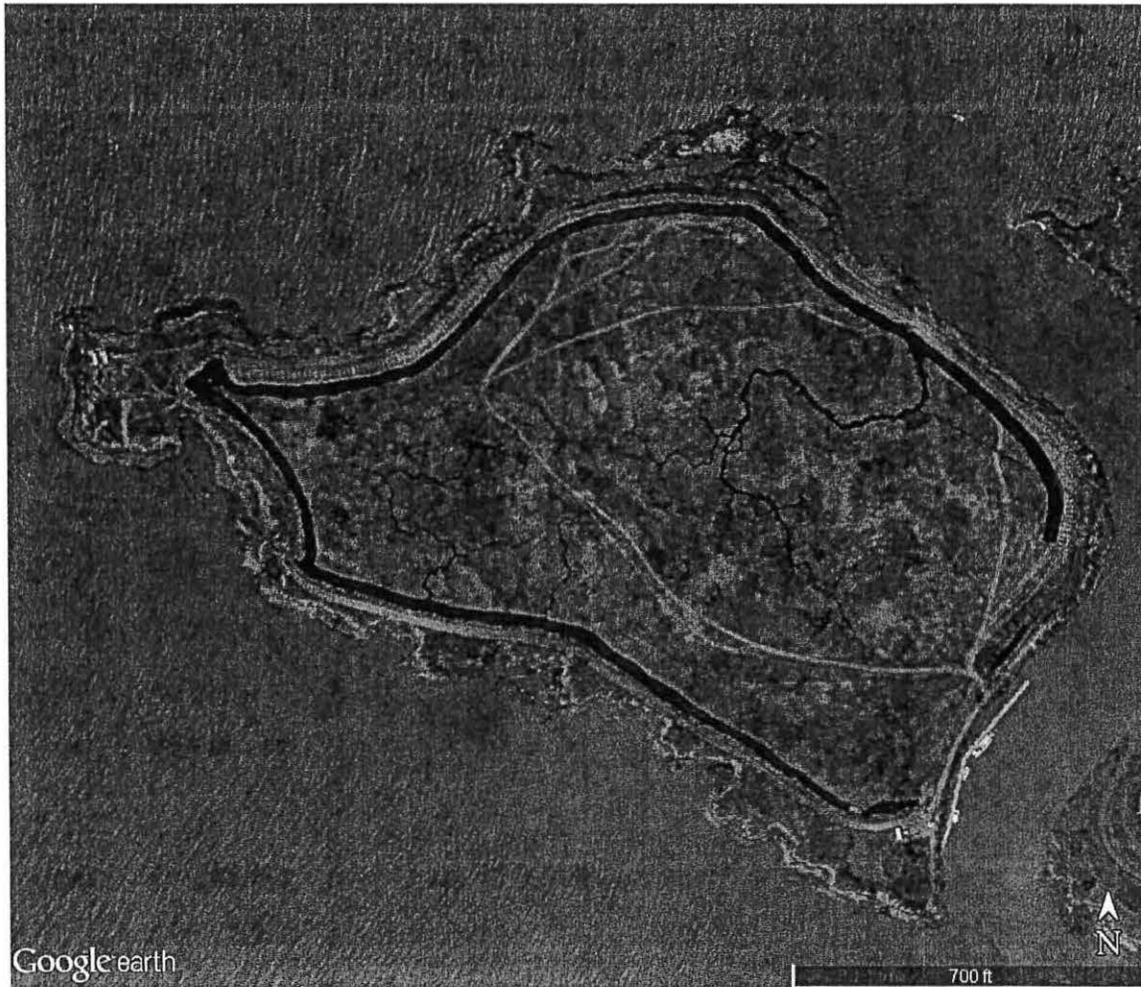
**August 23, 2014:** Levee construction around the island is nearly complete, except for the levee's east side. The slough at the island's north side has been cut off from tidal action. (Google Earth)

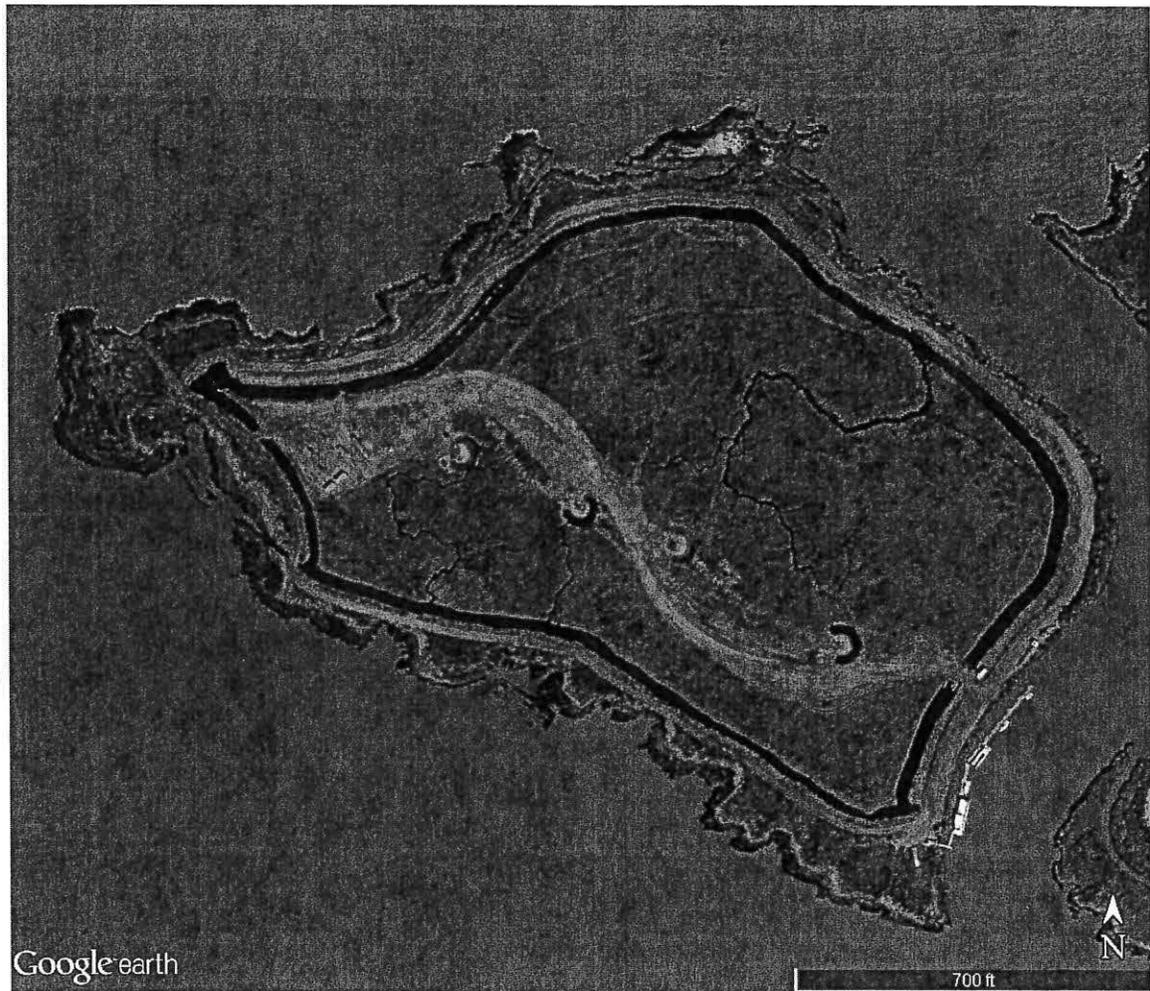
been leveed from tidal action. The site was fully open to the tides by 1981, and was largely unchanged until the construction of the new levee in 2014/2015. A photograph taken in April 2015 shows further grading, removal of vegetation, and excavation of ponds in the now-diked marsh plain.

**April 1, 2015:** Levee construction is complete and the island is now fully diked off from tidal action. Heavy equipment criss-crosses the marsh plain, and excavators have cut 4 crescent-shaped ponds in the marsh approximately 80 feet in diameter. What appears to be four large storage trailers are present in the western portion of the now-diked marsh. (Google Earth)
