Conditions at Point Buckler

October 16, 2015

Prepared on behalf of:
Point Buckler Club, LLC

Prepared by:
Applied Water Resources Corporation
2363 Mariner Square Dr., Suite 245, Alameda CA 94501

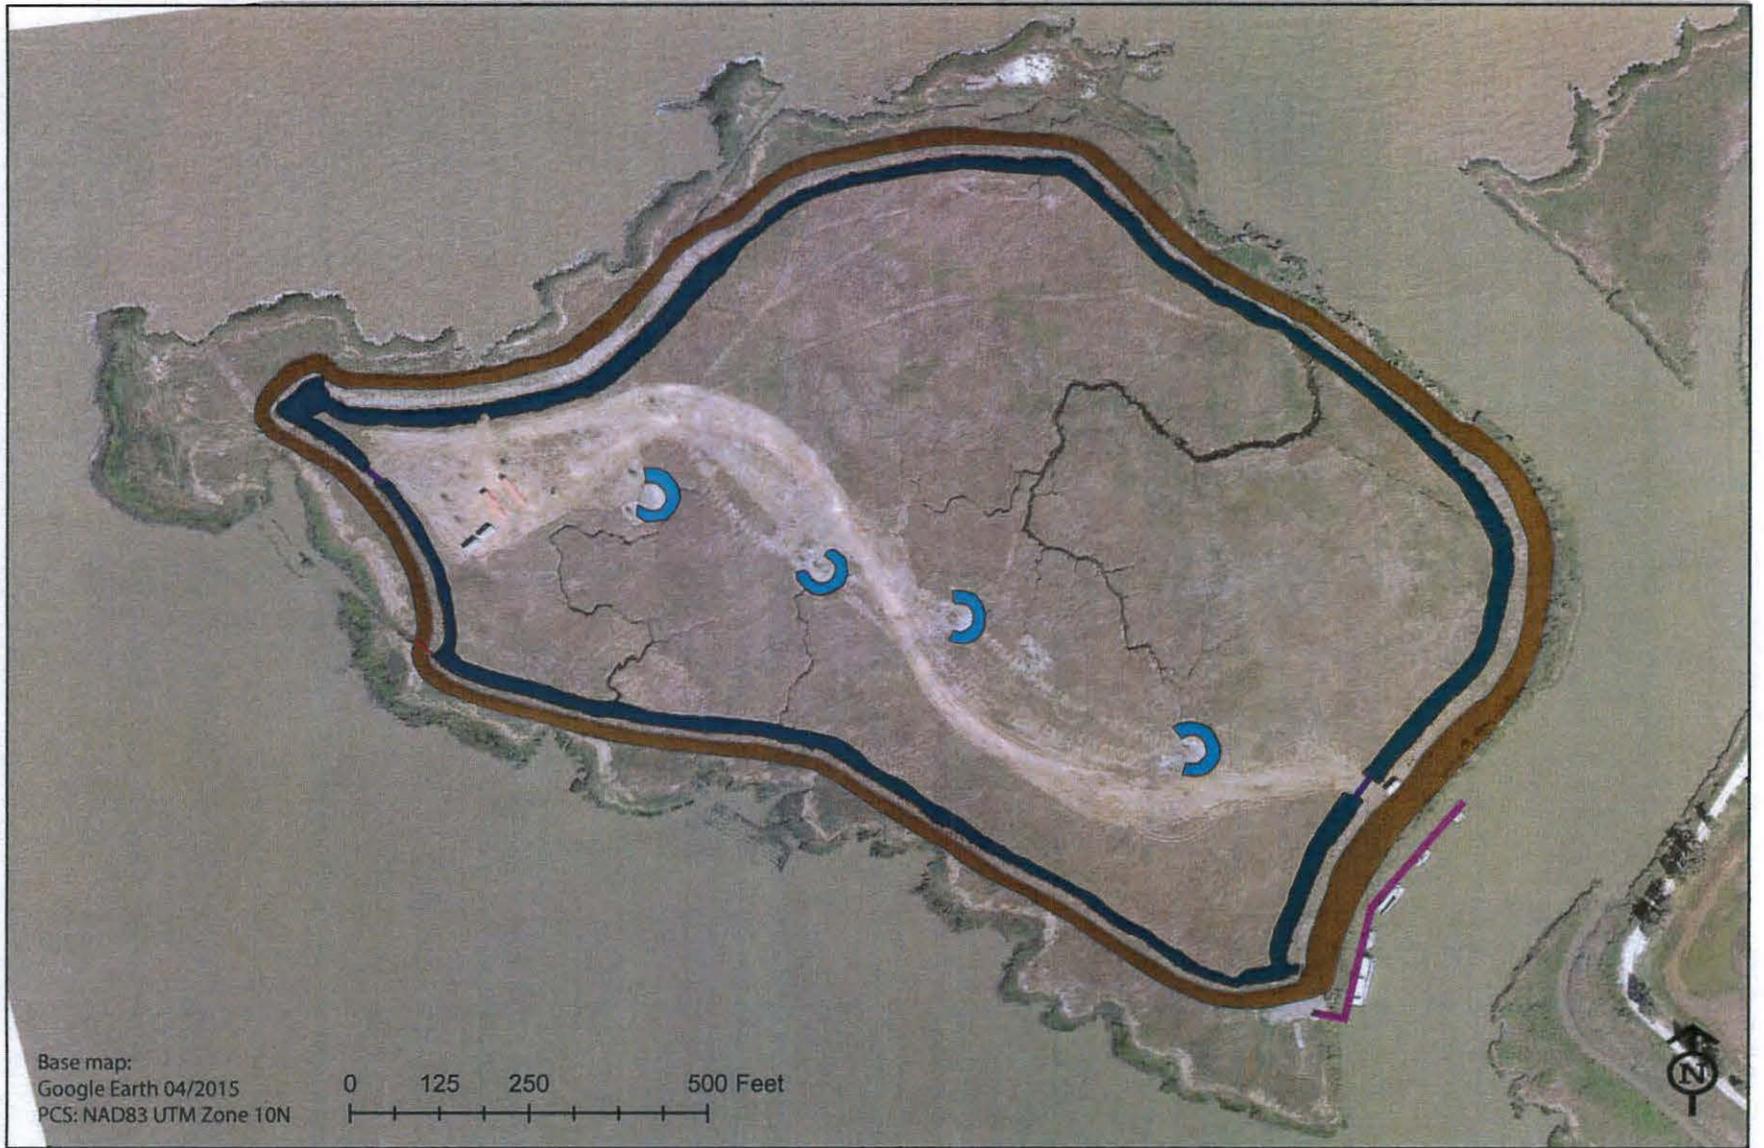
Figure - 1
 Locations of
 Recent Activities
 Point Buckler, CA

This section discusses the recent activities at the Island. Locations of these activities are shown on Figure 1.

Levee repair activities occurred in 2014. The repaired levee system is approximately 4,730 feet in length and spoils from the excavation of the repaired ditch system were used for the repair. Approximately 58% of the repaired levee system is located in its historical location, while approximately 42% is located further inland to avoid filling in the bay. Approximately 305 feet of the repaired levee system was located in the old ditch system's footprint.

Ditch repair activities occurred at the same time as levee repair activities because spoils were used to repair the levee system. A functional 24-inch floodgate was found in the southwest portion of the Island and was replaced with new flaps on each end to allow for water to enter the ditch system. Two 24-inch diameter steel pipe culverts were also installed to allow for water circulation on the Island.

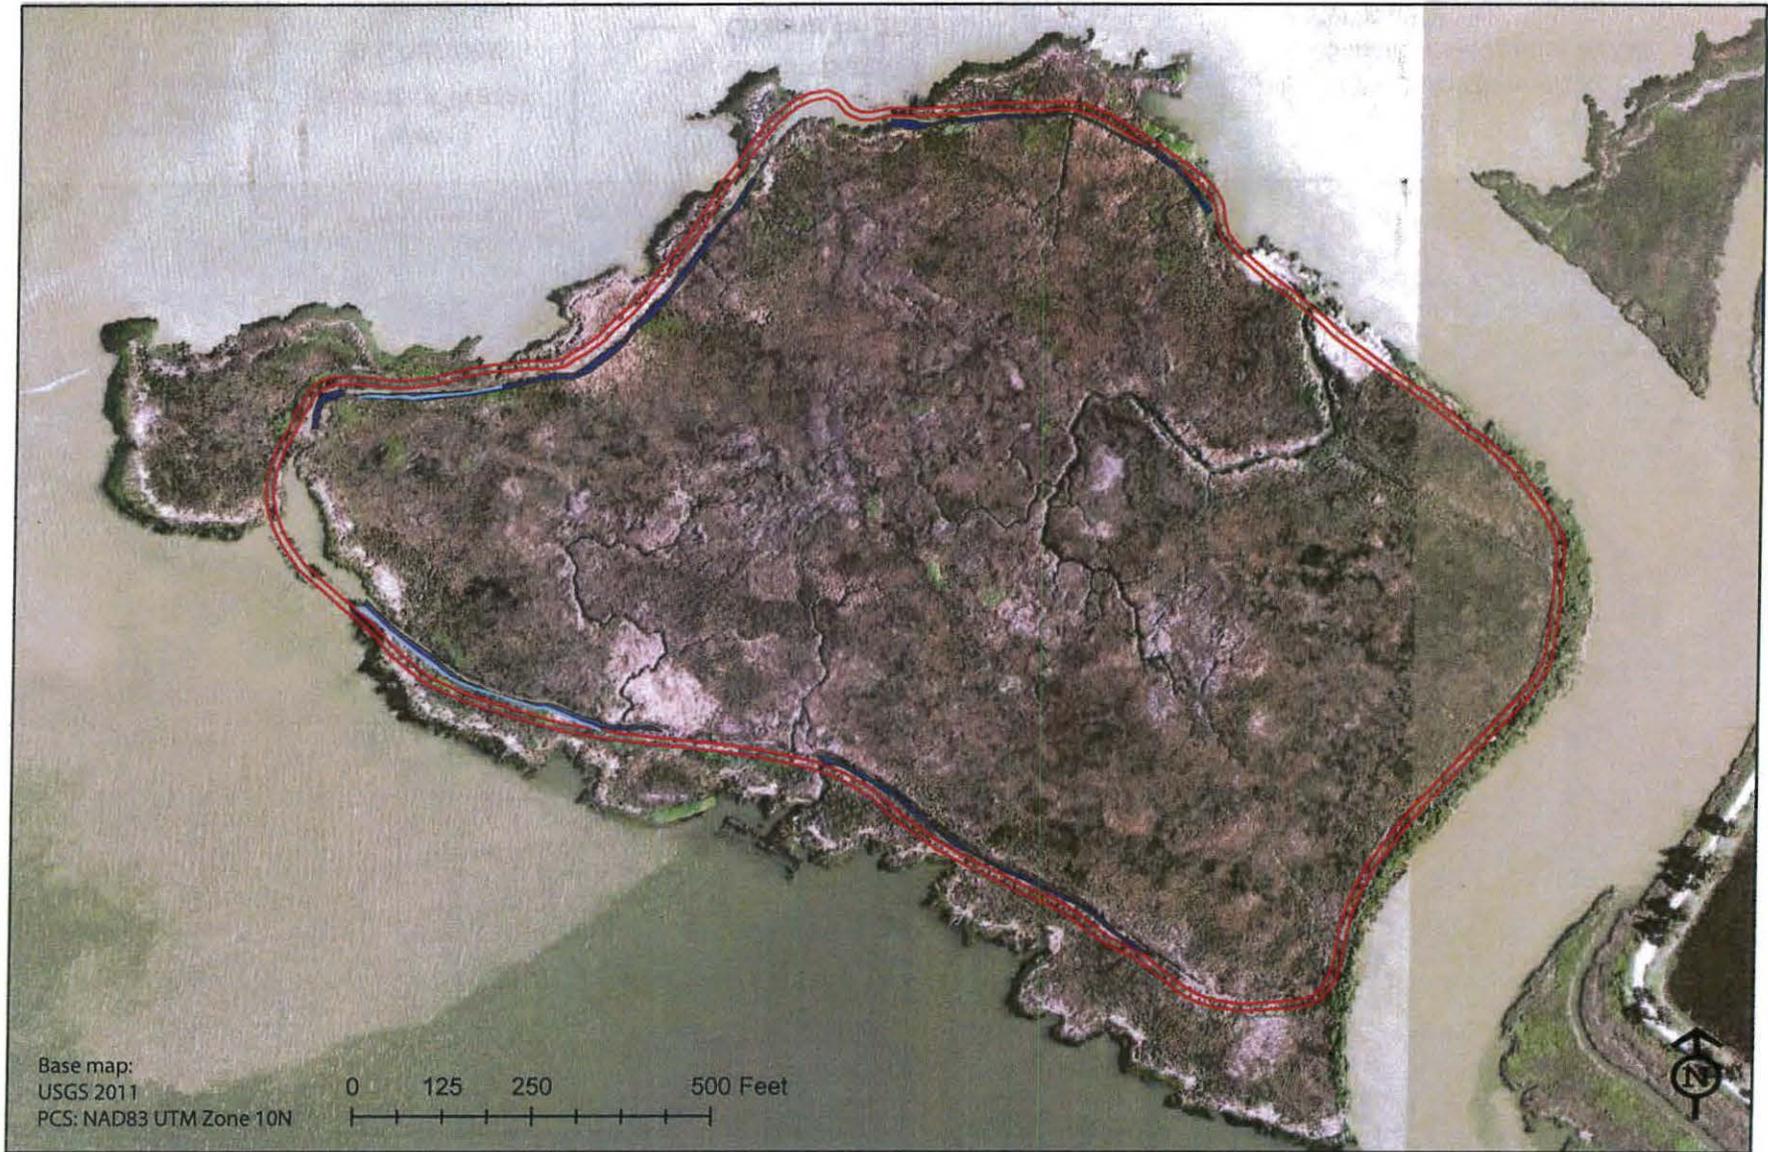
Figure - 2
Extent of Water in
Old Ditch System
Point Buckler, CA

Figure 2 depicts the extent of water present in the old ditch system at MLLW and MHW. Figure 3 depicts the extent of water present in the channels at MLLW and MHW. Figure 4 depicts the areas where fill materials were placed into waters of the State.

Prior to the recent repair of the levee and ditch systems, there was approximately 4,200 feet of old ditch system that was bounded on both sides by land. Of this, approximately 601 feet of the old ditch system contained water at MLLW and 2,321 feet of the old ditch system contained water at MHW, per the 2013 NOAA photos.

Biologists consider the wetted edge of a channel to provide potential habitat and nutrient exchange between ground water and surface water. Evaluated from the perspective of a wetted edge, approximately 1,203 feet of the old ditch system provided a wetted edge at MLLW and 4,642 feet of the old ditch system provided a wetted edge at MHW, per the 2013 NOAA photos. Recent activities at the Island have repaired the ditch system, which now consistently contains water all the time. As a result, the current length of the repaired ditch system is 4,380 feet, which provides approximately 9,058 feet of wetted edge.

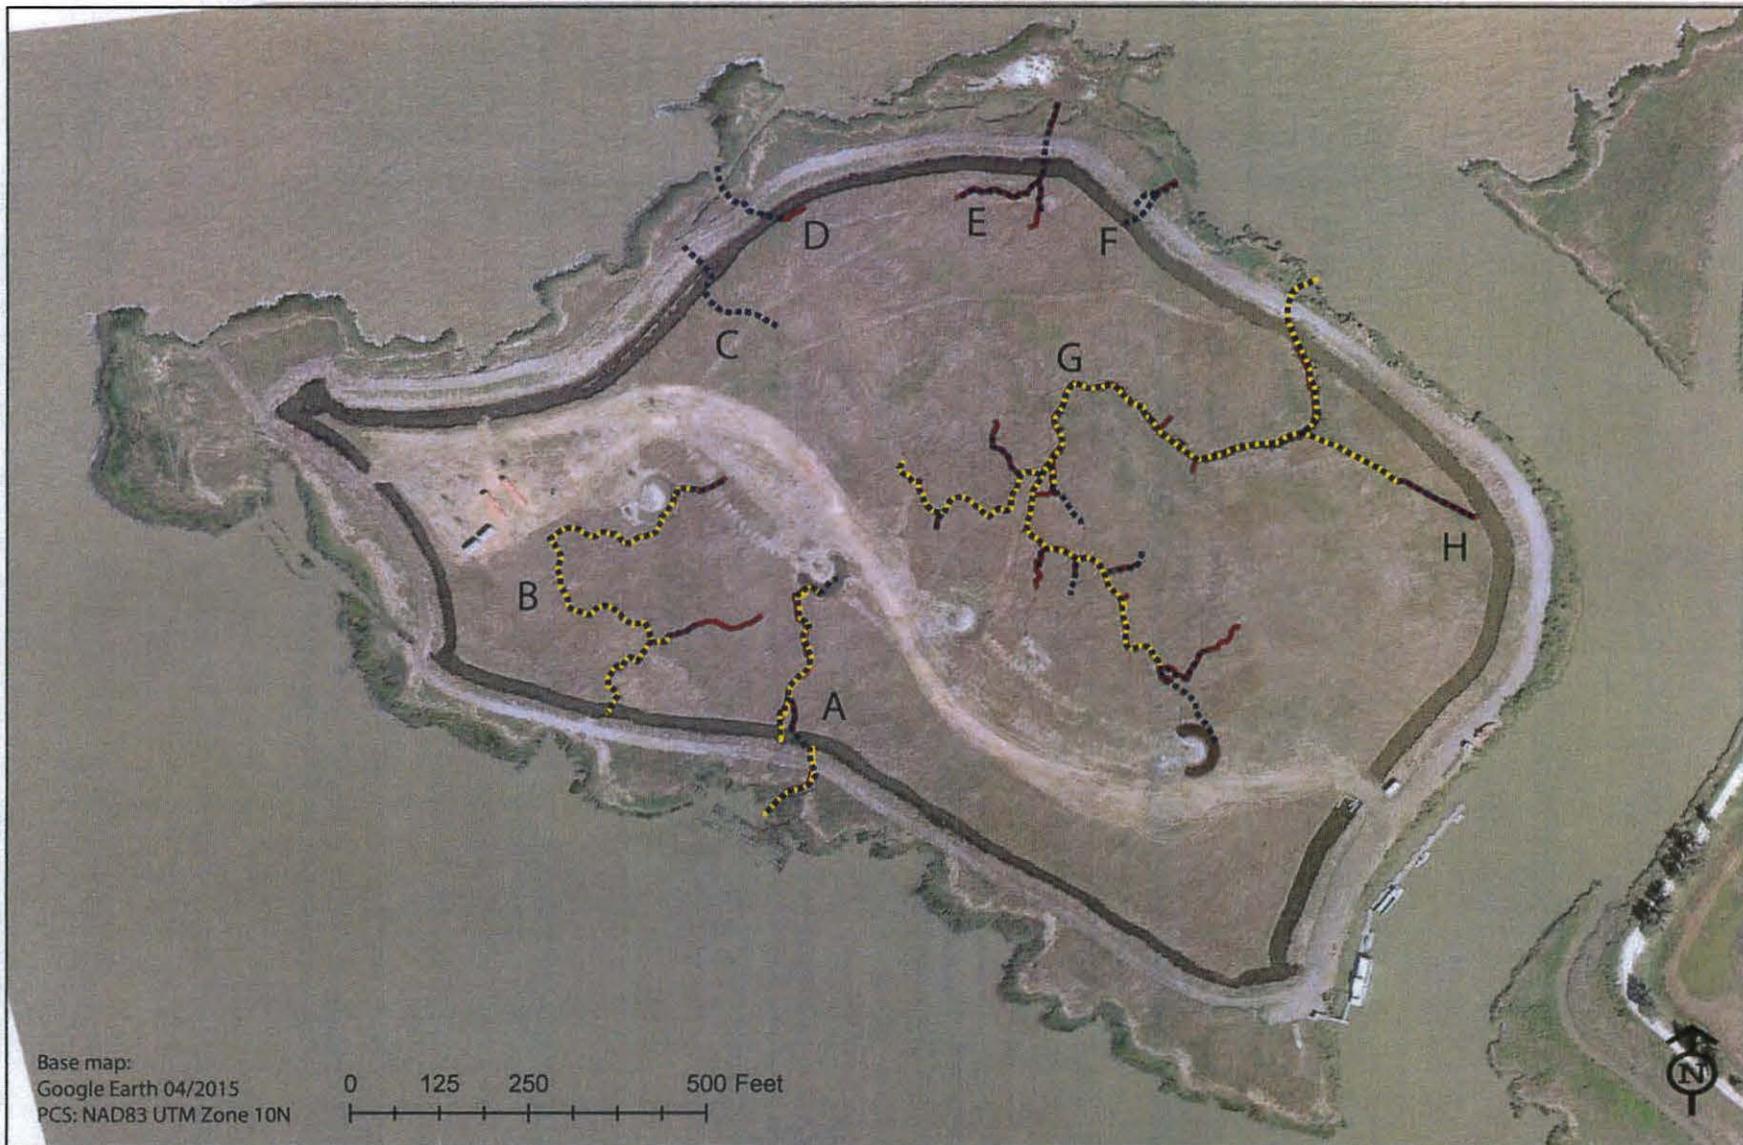
Figure - 3
 Extent of Water
 in Channels
 Point Buckler, CA

A similar evaluation measured the length of the channels and wetted edge at MLLW and MHW in the 2013 NOAA photos, and under the current conditions. Finally, recent activities excavated four ponds, and two consistently contain water. The following table summarizes these measurements:

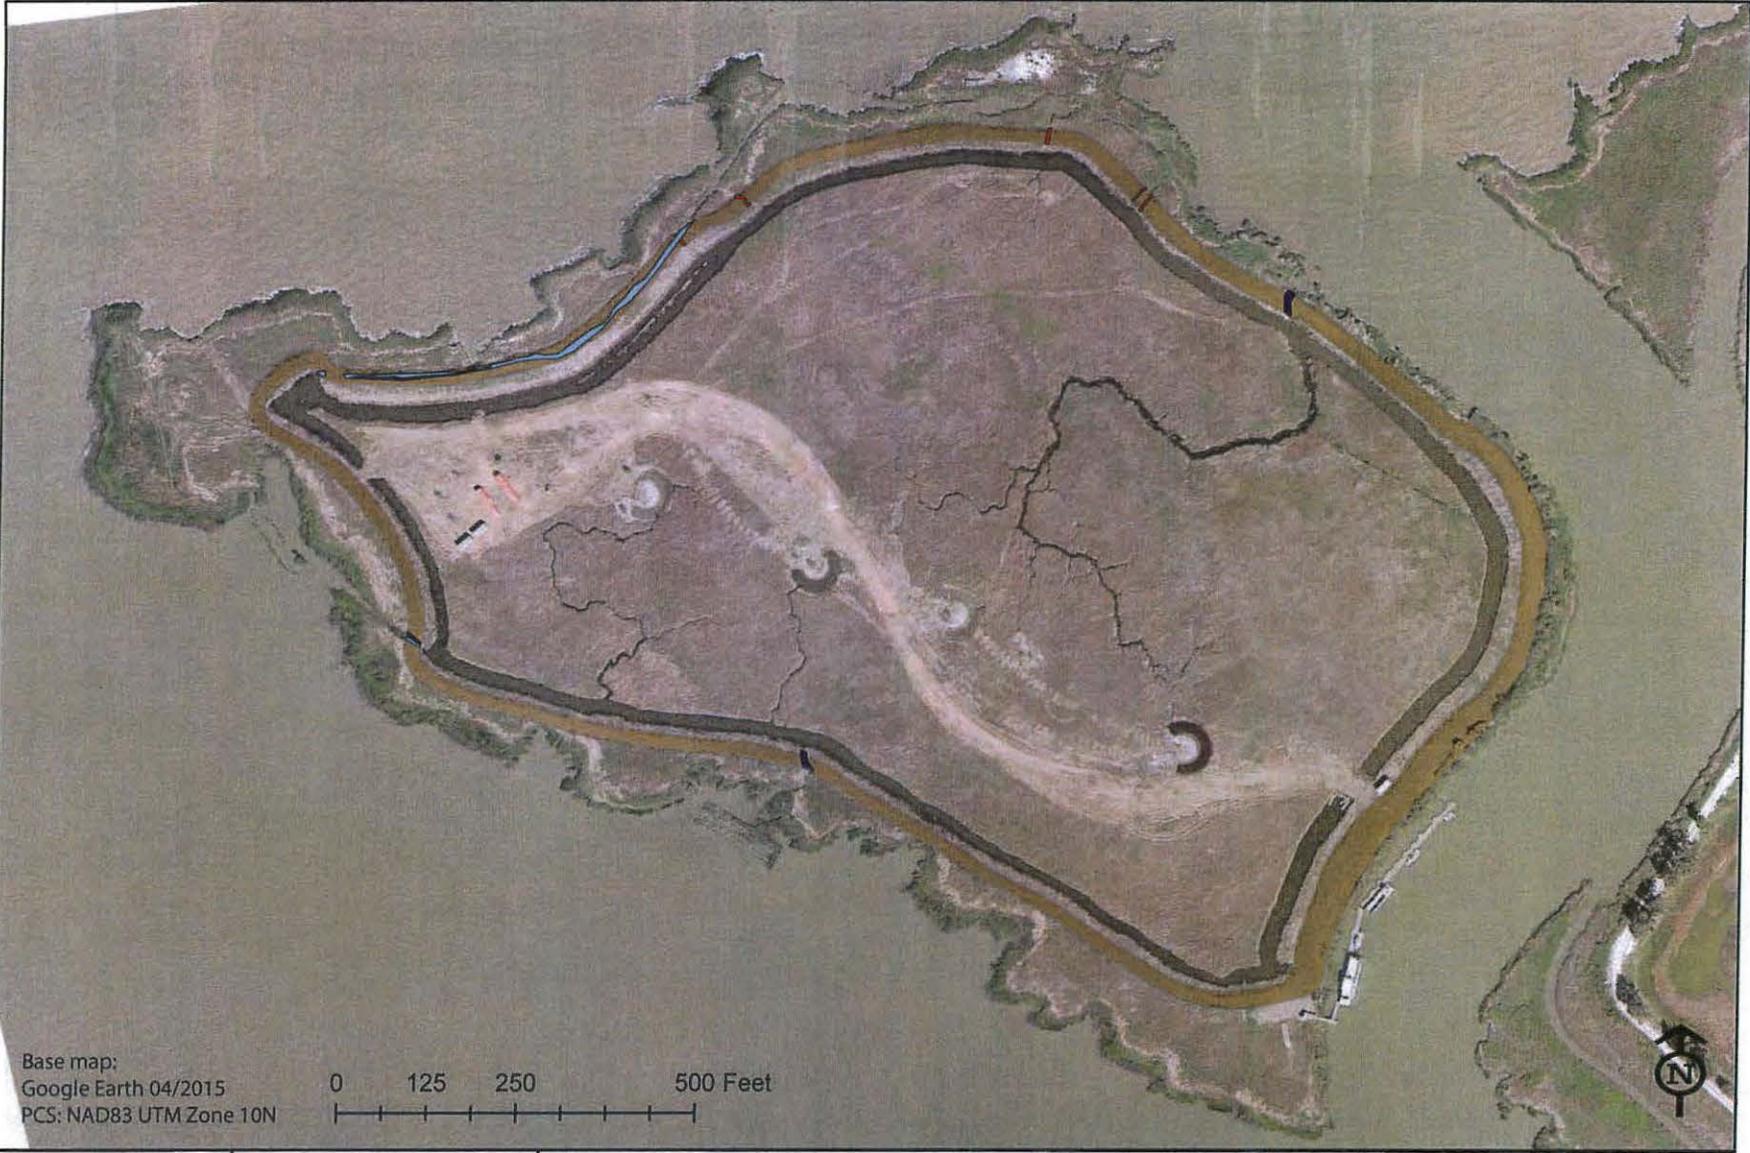
Figure - 4
 Areas of Fill Placed into
 Waters of the State
 Point Buckler, CA

The area of fill was identified by overlaying the aerial photos showing the extent of water (2013 NOAA photos) and the current conditions (2015 GEarth). Areas where the extent of water in old ditch system and channel are co-located with fill used to repair the levee system are considered the area where fill was placed into waters of the State. The thickness of fill is assumed to be the full tidal range plus 1 foot in areas where water is present at both MHW and MLLW. The thickness of fill is assumed to be at half the tidal range in areas where the old ditch system and channel appear to have water at MHW but have no water at MLLW. The calculation of the volume of fill material placed into waters of the State is simply the product of multiplying the area by the thickness.

The NOAA 2013 photos reveal reaches of the old ditch system where no water appears to be present at MHW and MLLW, such as along the eastern margin of the Island. It appears that these areas silted in over time, and based on the 2011 and 2013 aerial photos many of the areas appear to be vegetated. Consequently, in areas where the repaired levee system overlies these silted in portions of the old ditch system, no fill was introduced to waters of the State.

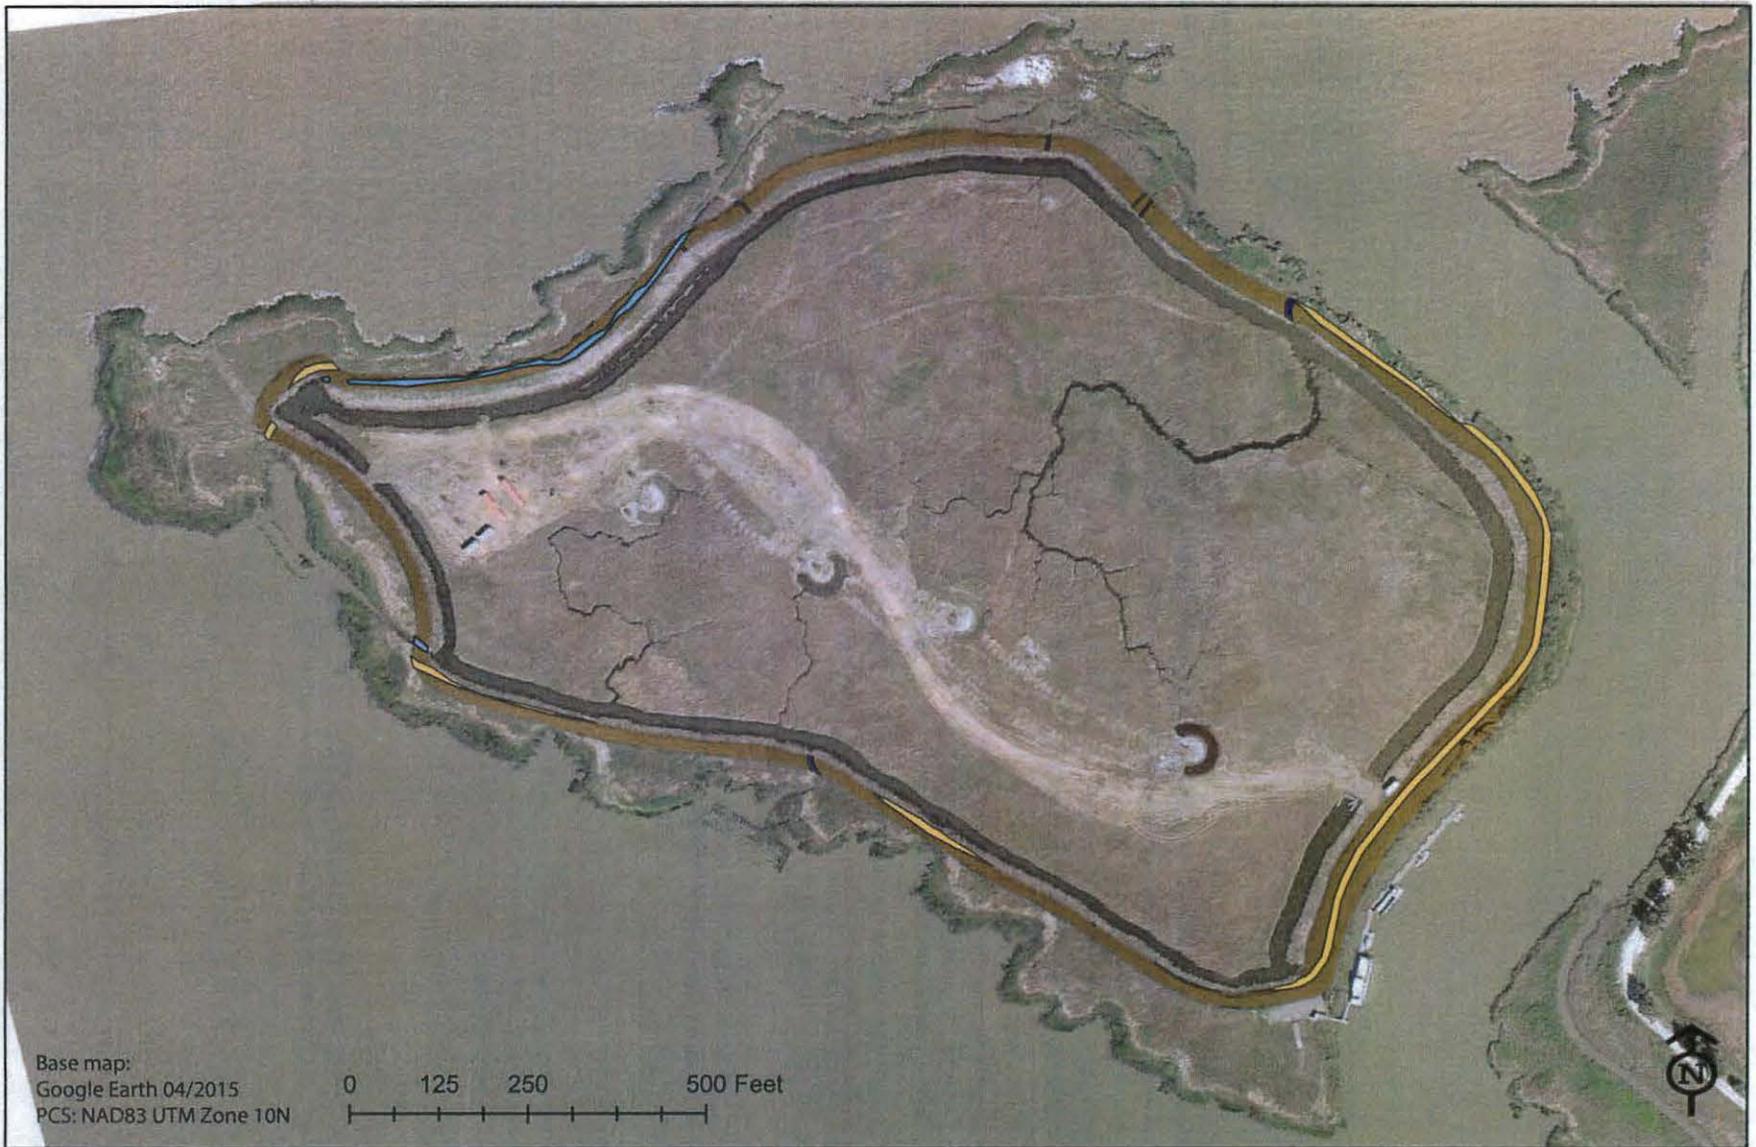
Figure - 6
**Areas of
 Covered Vegetation**
 Point Buckler, CA

Per conversation with John Sweeney, approximately 50% of the area of the old levee system was covered with vegetation, therefore 50% of the area of coincidence of old levee system and repaired levee system is interpreted to be removed vegetation. Vegetation is also interpreted to have been removed where the repaired levee system is located on areas of the Island that were not previously ditch or levee, as shown on Figure 6.

Repaired levee system	2.89
Old ditch system containing no vegetation and coinciding with repaired levee system	0.10
Old levee system containing no vegetation and coinciding with repaired levee system	0.19
Channels containing no vegetation and coinciding with levee ditch system	0.02
Total area of vegetation covered	2.58 acres
