CLUB #801

ANNIE MASON POINT CLUB

PRESENT CLUB CONDITIONS

CONSERVATION PLAN MAP

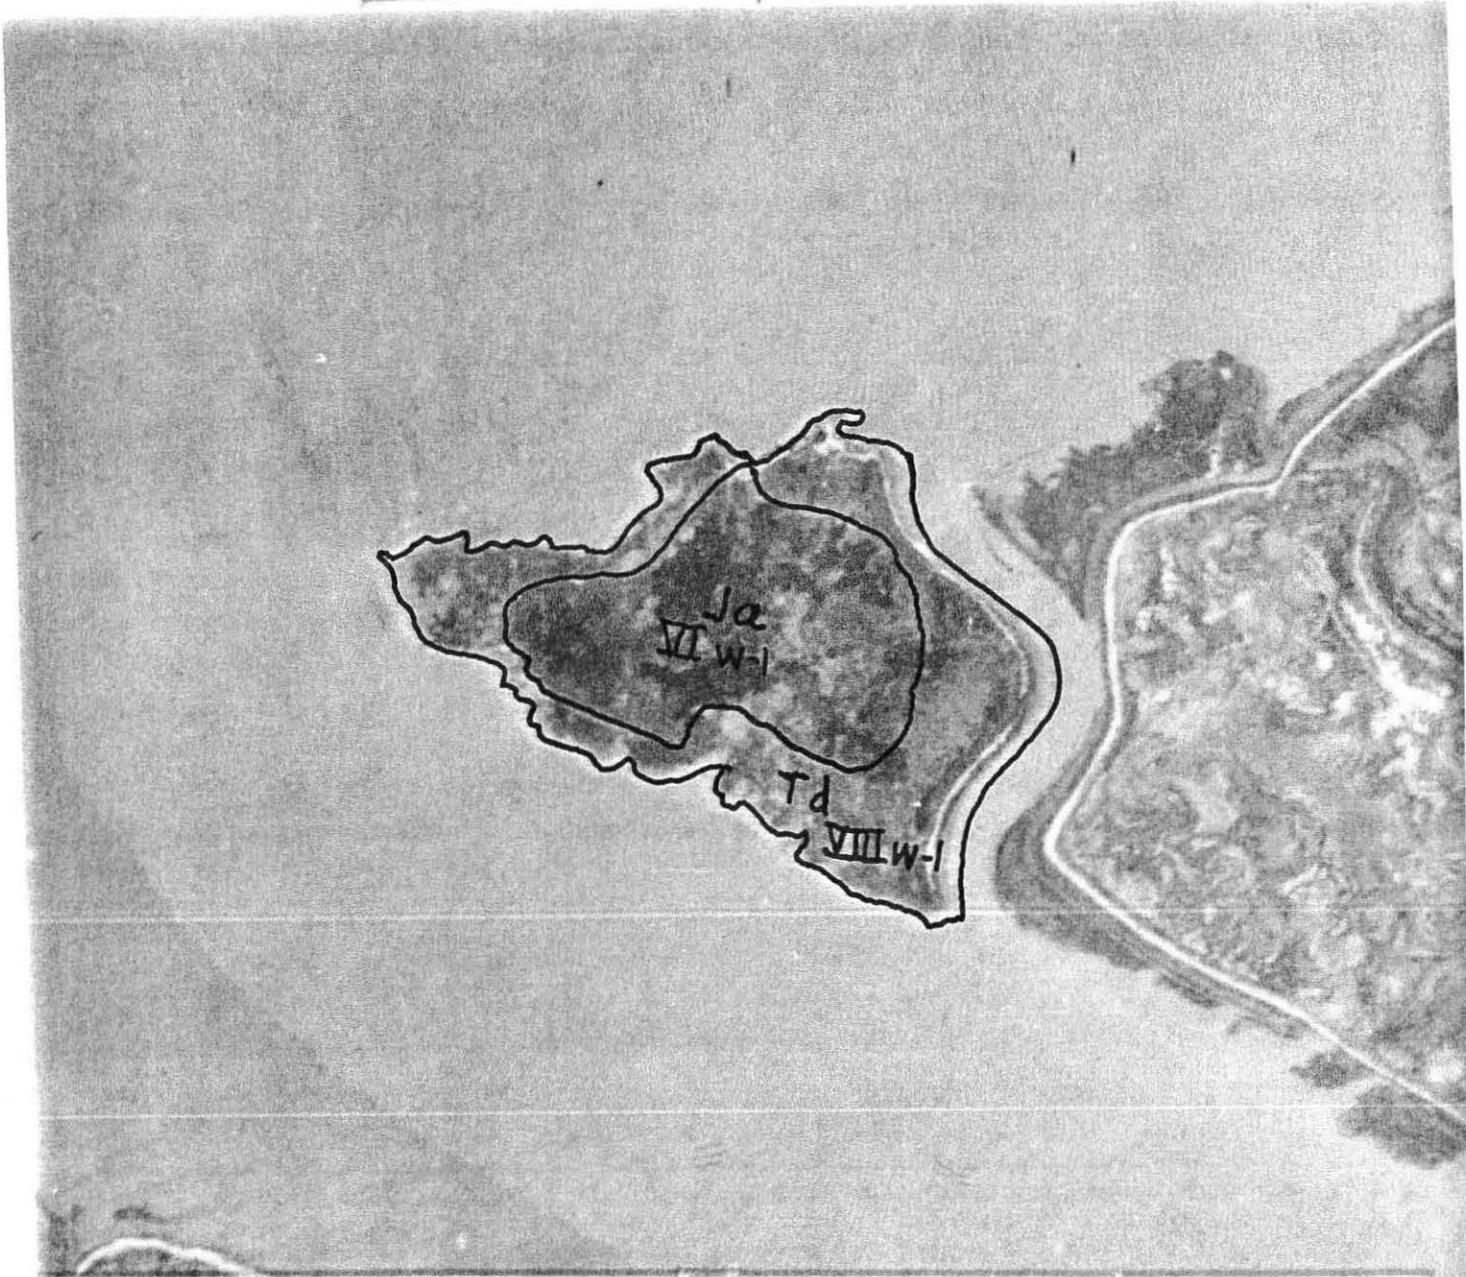
SOIL and CAPABILITY MAP SUMMARY

Owner Taylor, James F. Operator _____
 County Solano State CA
 Soil survey sheet(s) or code nos. _____ Approximate scale 1"=660'
 Prepared by U.S. Department of Agriculture Soil Conservation Service cooperating
 with Suisun Resource Conservation District

Land Capability Unit	Symbol on Map	Soil Name	Effective Depth	Soil Profile			Average Slope in %	Erosion Status	Suitable Land Uses or Crops	Limiting Factors or Remarks
				Texture		A.W.C.* Inches				
				Surface	Subsoil					
VIw-1	Ja	Joice Muck	+60"	clayey muck	clayey muck	14-15"	0-1%	slight	1) Wildlife, wetland habitat. 2) Recreation.	1) Rooting depth restricted by high water table. 2) Requires drainage and leaching of soil salts for proper management. 3) Levees and tidegates are necessary for water control. 4) Only salt tolerant vegetation should be managed for.
VIIIw-1	Td	Tidal Marsh	-----	-----variable-----	-----	1-2"	0-1%	NONE	1) Wildlife wetland habitat.	1) Strongly saline land type. 2) Mud flats, subject to tidal inundation.

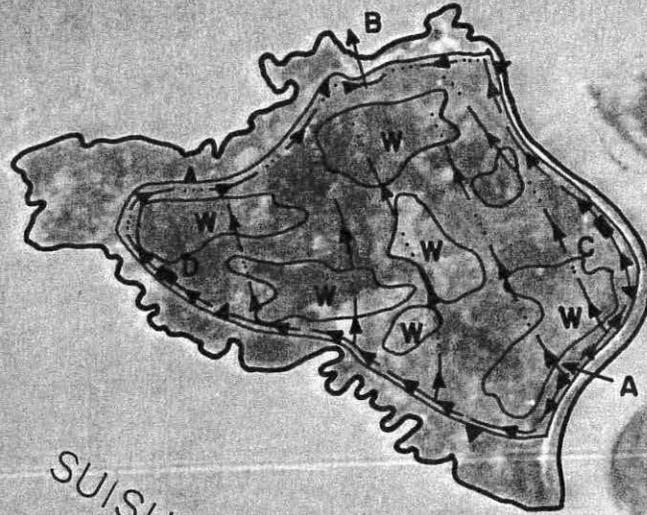
Owner Taylor, James F. Operator _____
 County Solano State CA Date _____
 Approximate acres 51.51 Approximate scale 1"=660'
 Cooperating with Suisun Resource Conservation District _____
 Plan identification _____ Photo number _____
 Assisted by _____ USDA Soil Conservation Service

GRIZZLY BAY

SUISUN
CUTOFF

FLOODED AREA - 30ac

Annie Mason Point Club is a small lone club located on Buckley Island. It is contained within a single levee surrounded by Grizzly Bay to the north and Suisun Cutoff to the south. Structure A on the east side of the club functions as the main flood gate and brings water into the club via a perimeter ditch system. A system of interior ditches running from south to north further distributes water to the pond. Structure B is used to drain the club into Grizzly Bay. Two small check dams (C and D) are located in the perimeter ditch. These structures aid in circulation by putting a head on the inlet water and forcing it to circulate across the club in a south to north direction. Removing the boards in the dam enables the ditch to drain.

Due to limited access, an elevation survey was not done for this club. That being the case, the club's flood and drain capability could not be determined. However, using some assumptions, it is apparent that as the ponded area is very small, gates A and B would likely have to be only 24" in diameter to service this club effectively. Although structure B, the drain gate, must be set low enough to provide subsurface drainage of the pond.
