# ATTACHMENT A – PHOTOS TAKEN JUNE 7, 2023 BY JENN HYMAN, BCDC OF PONDS P2-12 AND P2-13

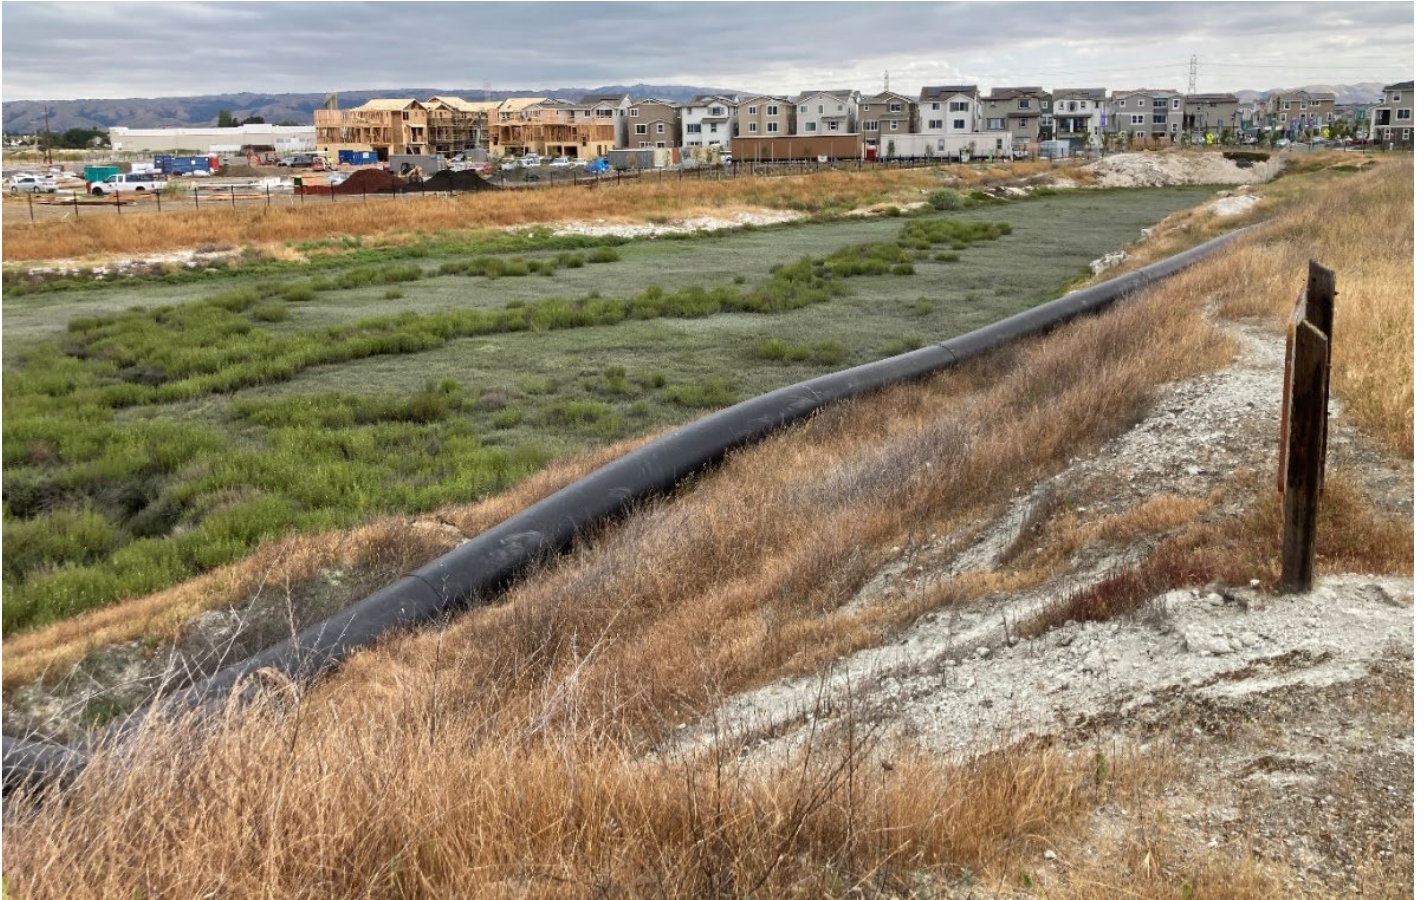
Photo 2. East end of canal on the north side of Pond P2-13, with pond berm on the right. The black pipeline is a Cargill process pipeline.

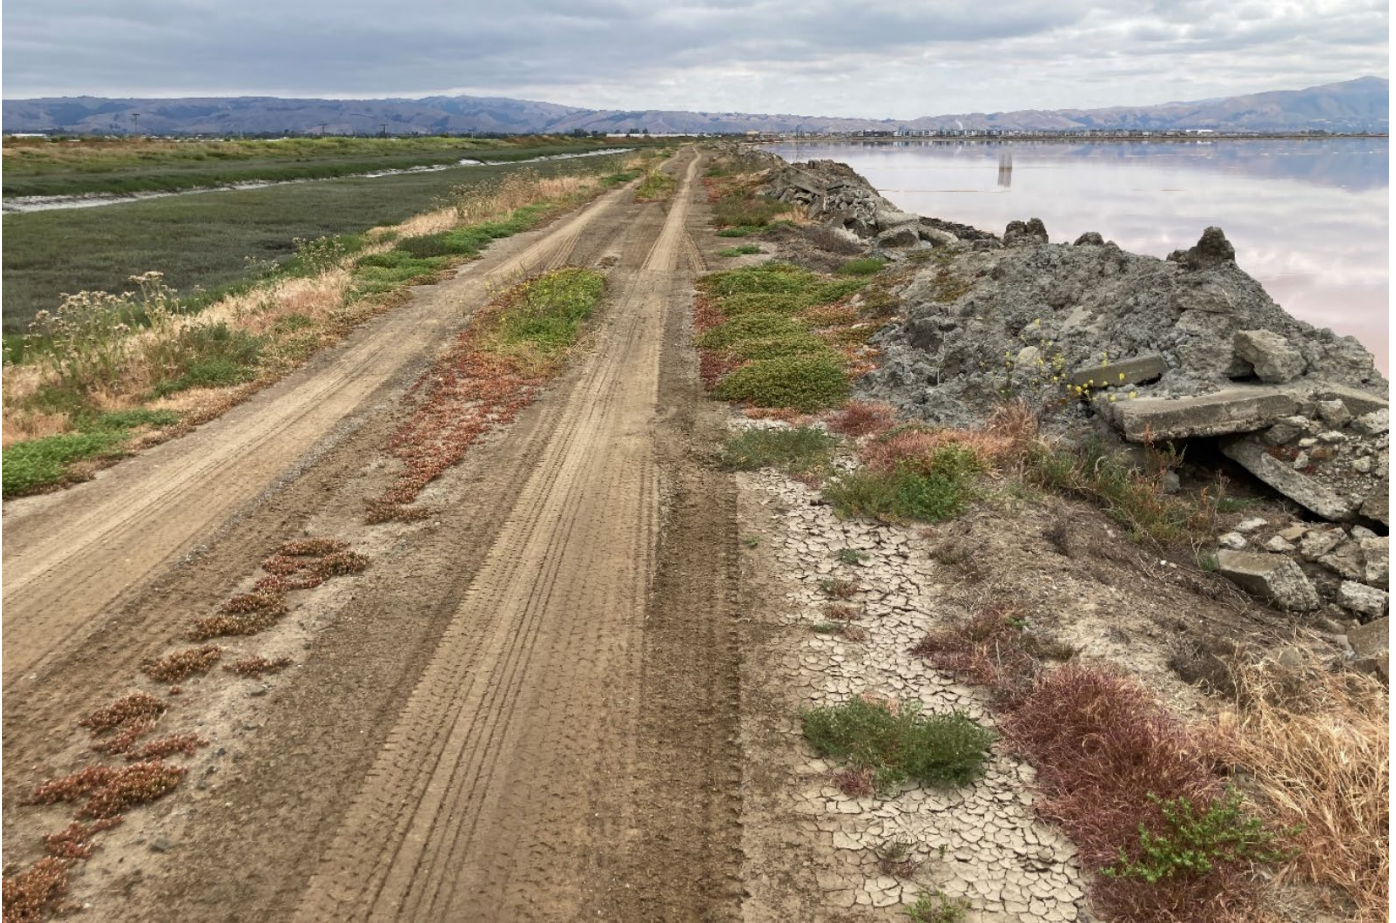
Photo 3. Looking east with the former barge canal on the left and Pond P2-13 on the right. This berm is drivable only during dry weather.

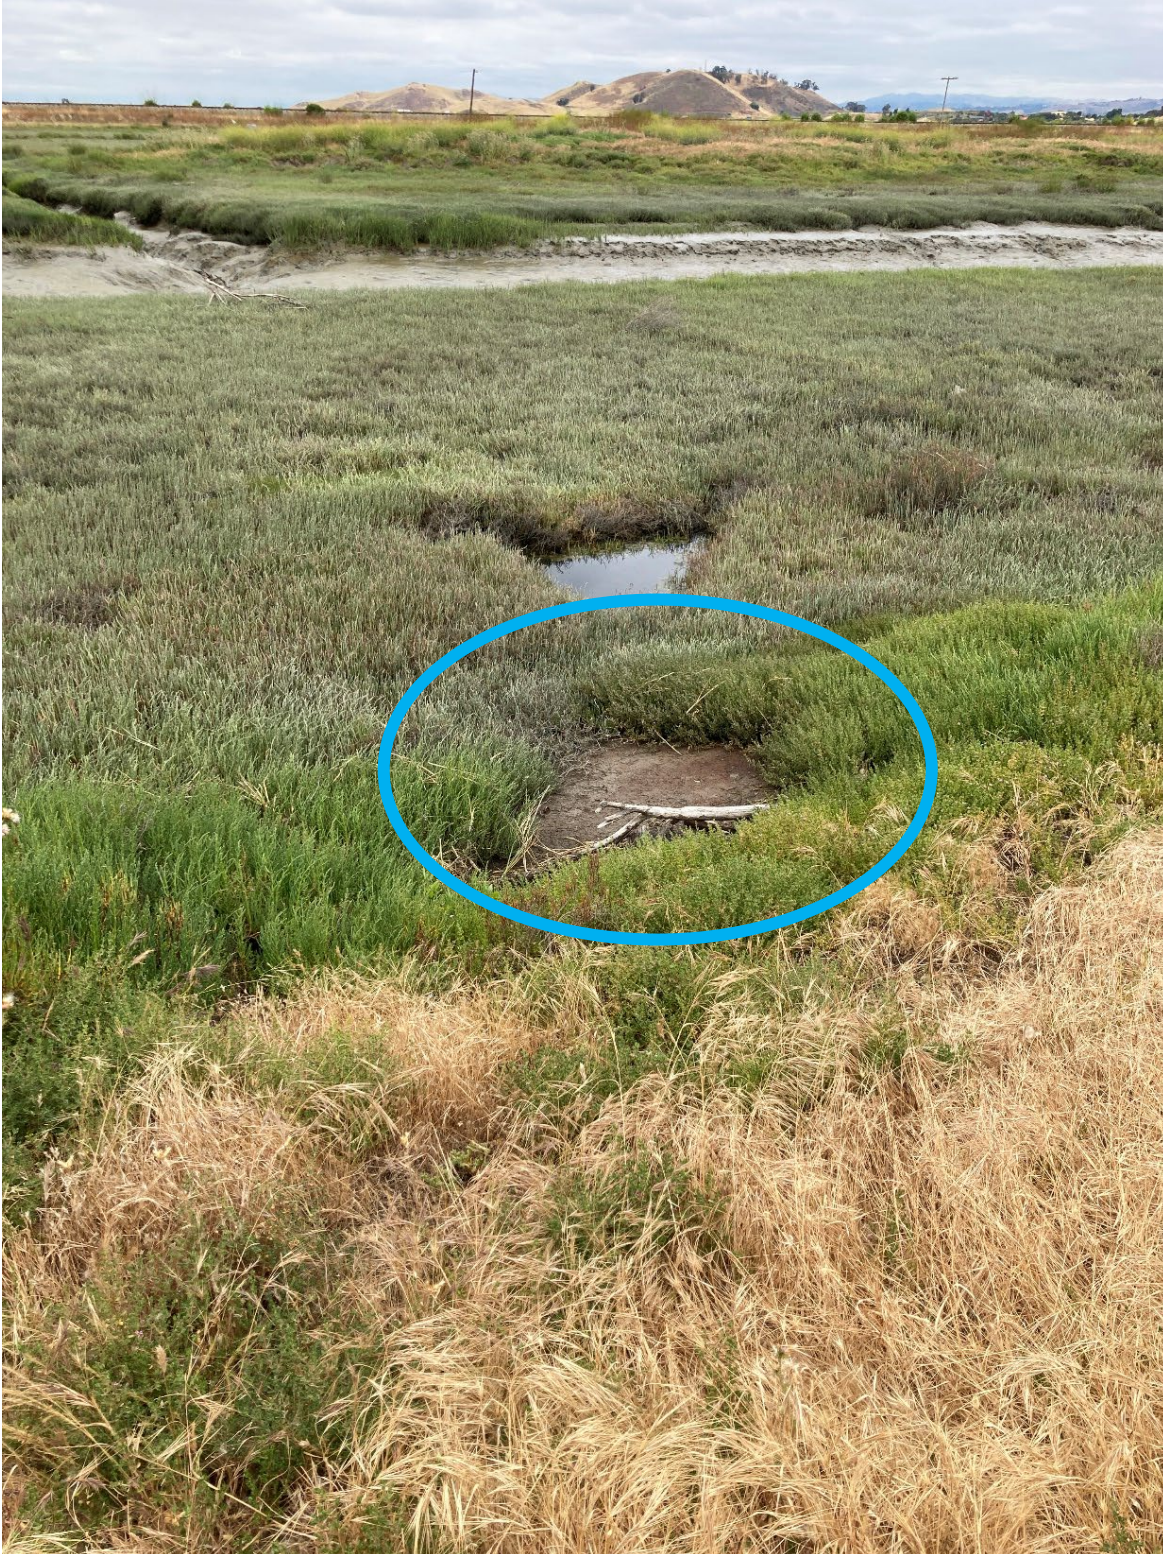
Photo 4. The brown bare spot in the wetland previously showed potential indications of a seep through the berm of Pond P2-13, which Cargill addressed through keying (berm coring).

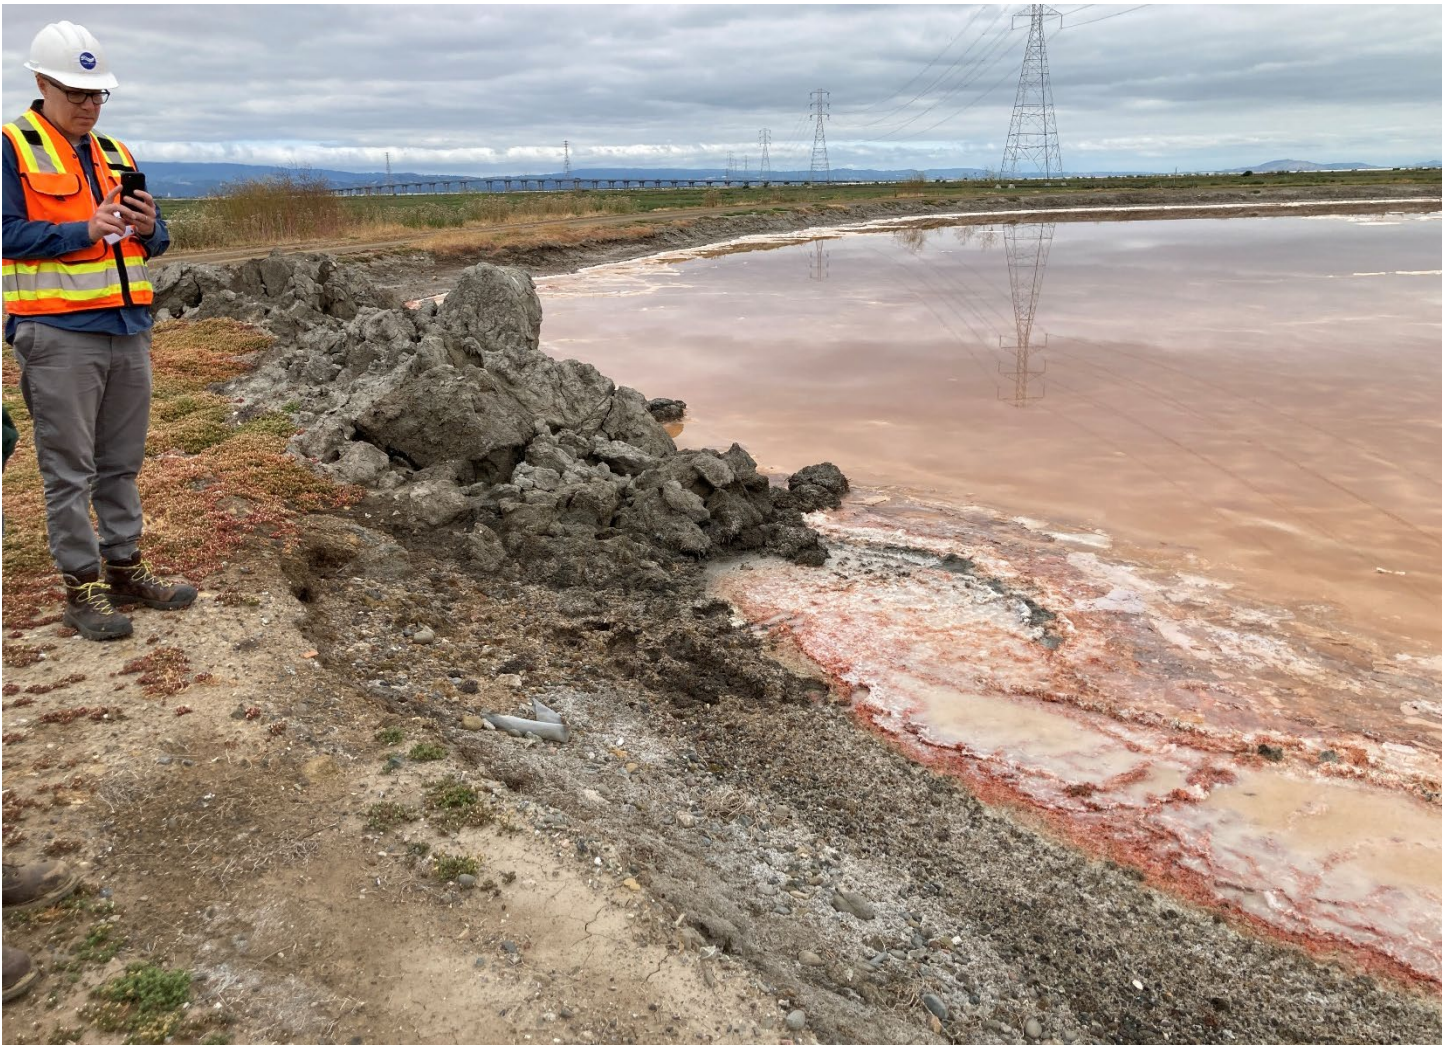
Photo 5. This photo shows the side cast from keying (berm coring) placed on the pond side of the berm at Pond P2-13. The pond has rainwater in it from the previous very rainy winter. The crystallized, solid mixed sea salts are visible at the edge and a few inches under the surface of the pond.

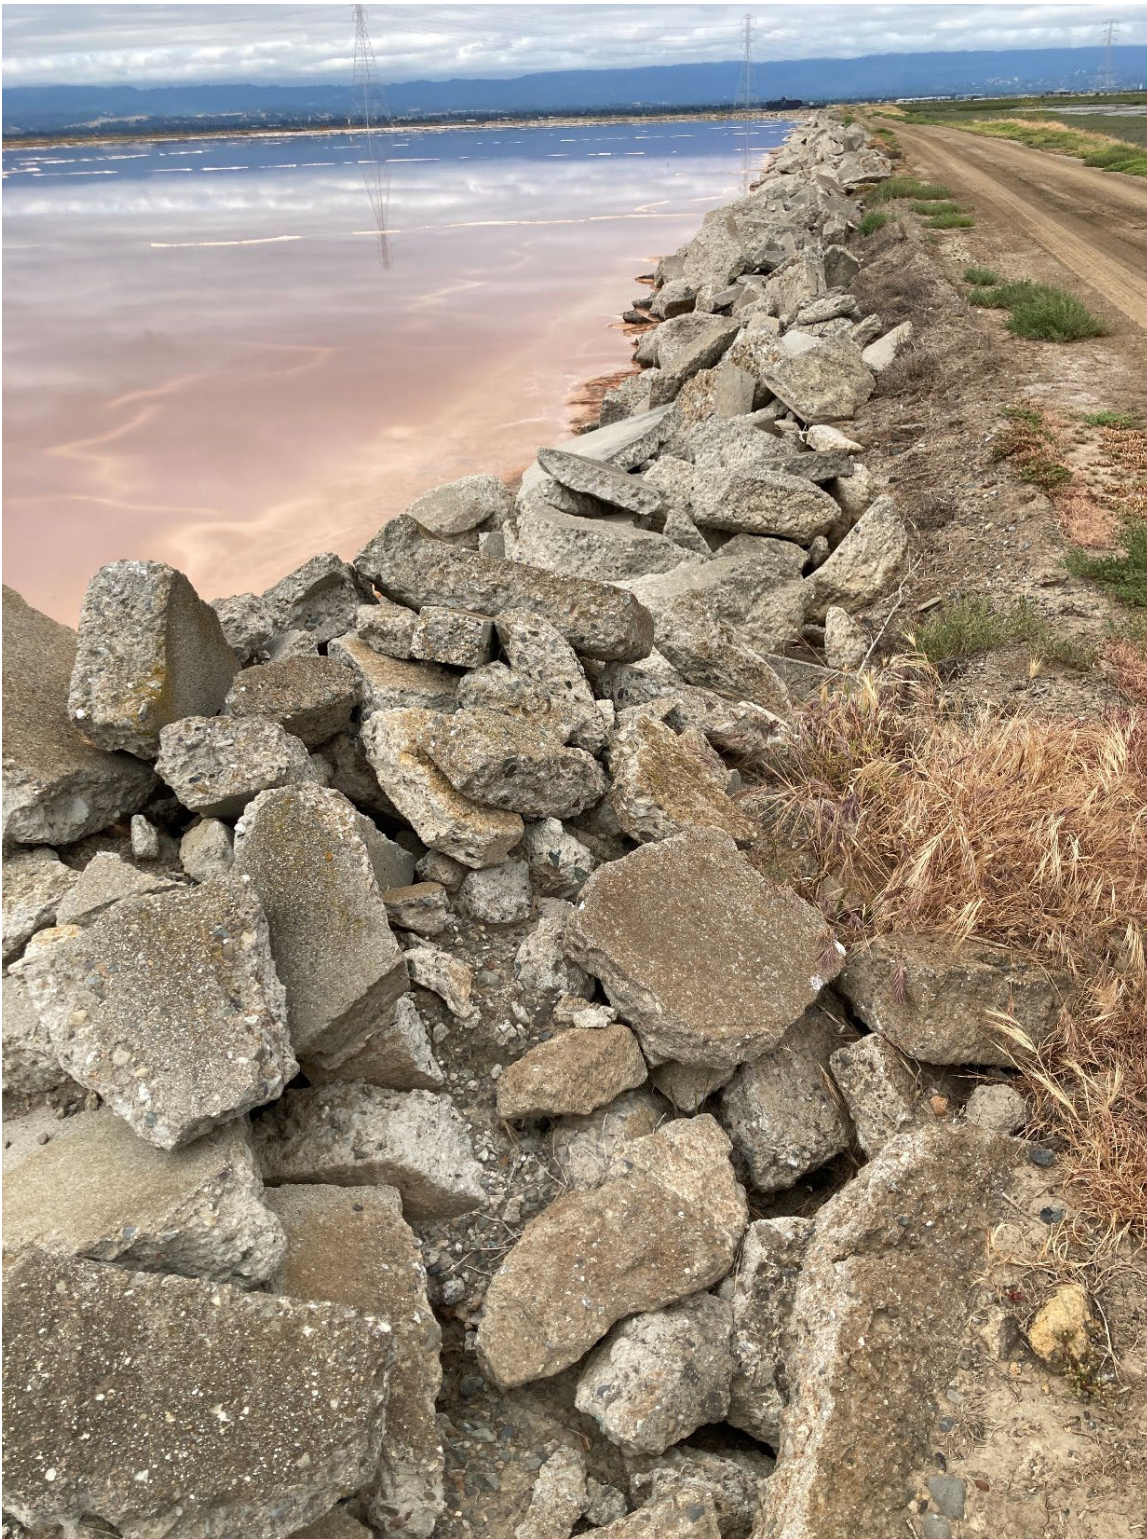
Photo 6. Example of interior berm riprap in Pond P2-13.

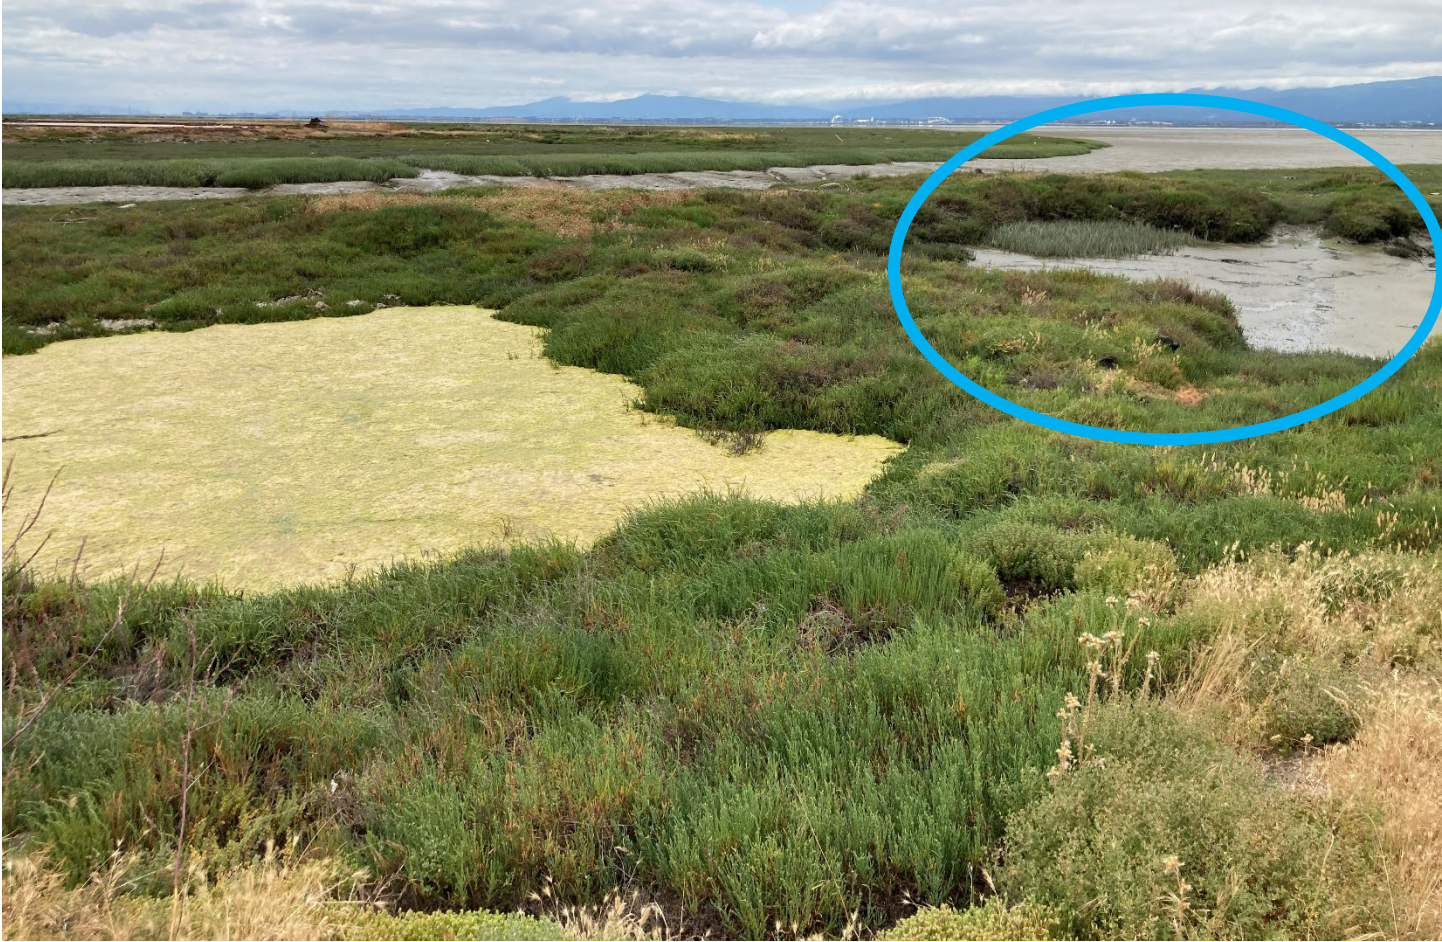
Photo 7. The Pond P2-13 lock, circled in blue. It has not been used in a very long time and has been taken over by tidal marsh.

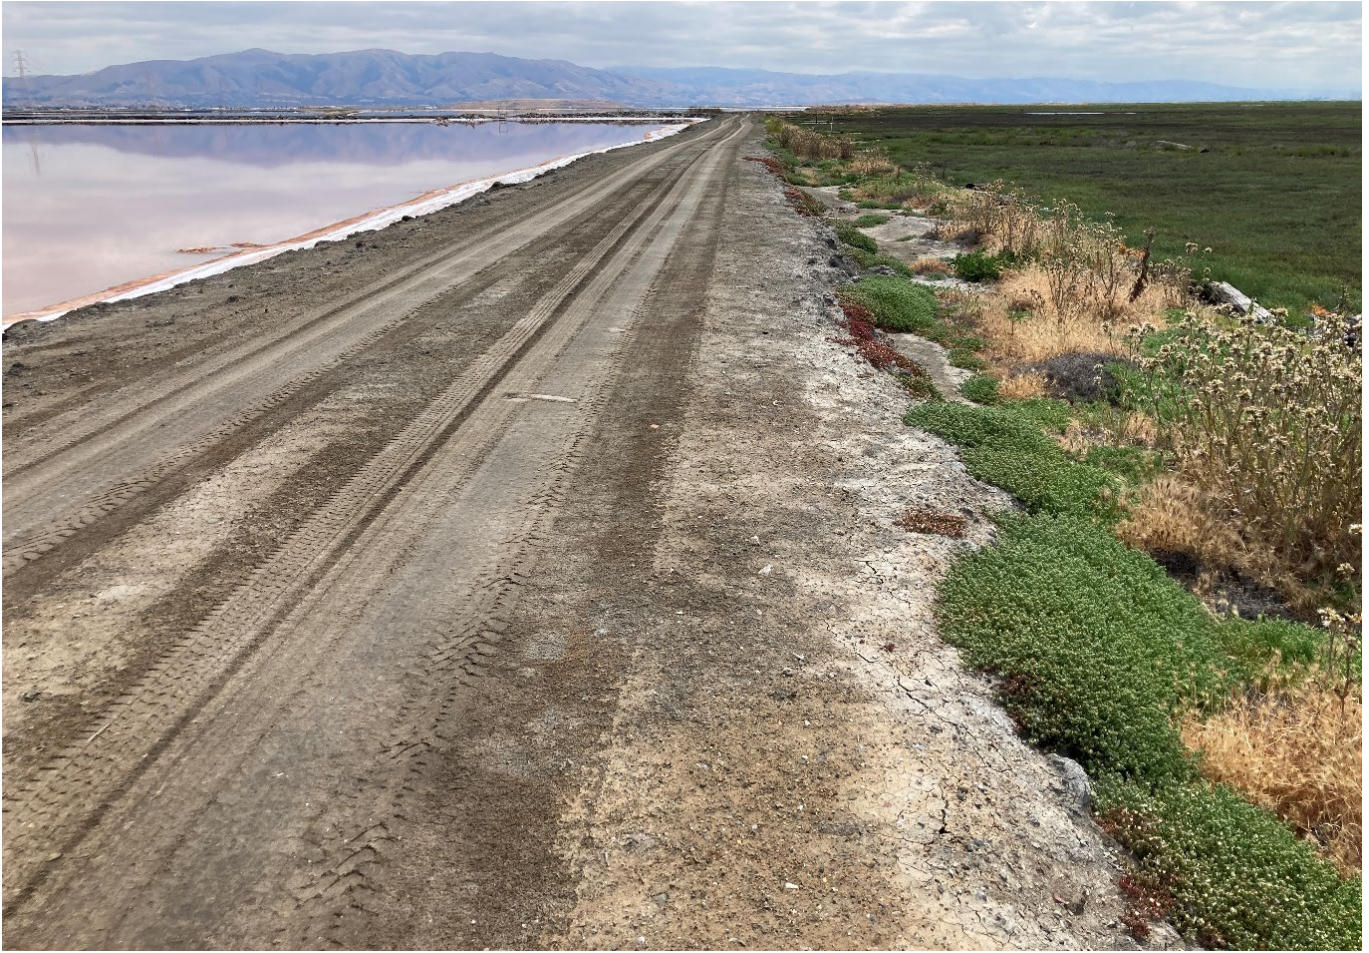
Photo 8. The outboard berm of Pond P2-12. It is drivable only during dry weather.

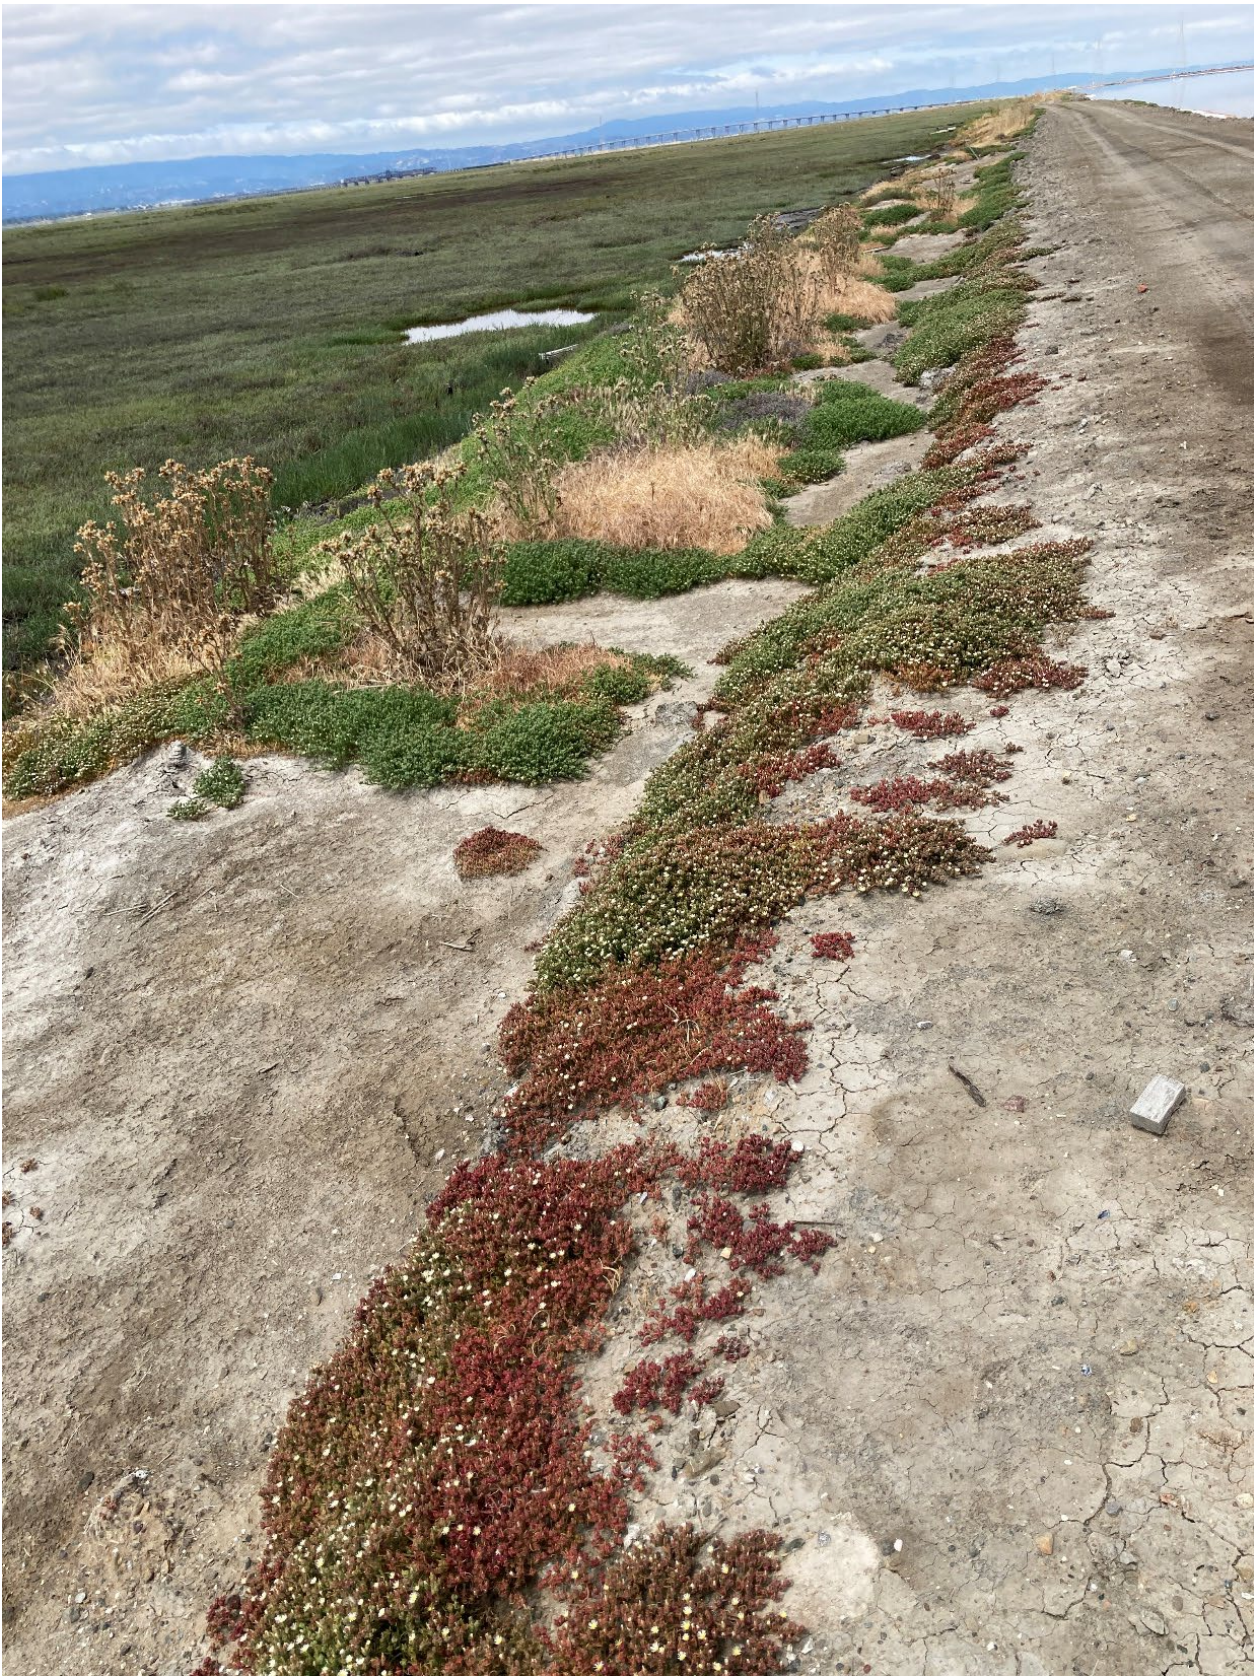
Photo 9. The outboard berm at Pond P2-12 showing the extensive tidal wetlands.
